# Carrickmines-Shanganagh River Flood Relief Scheme EIAR – Volume 3 Appendices

February 2025

This report relates to the Carrickmines-Shanganagh River Flood Relief Scheme commissioned by Dún Laoghaire-Rathdown County Council (DLRCC), on behalf of the Office of Public Works (OPW). Conor O'Neill and Bernadette O'Connell of JBA Consulting compiled this report, which was prepared by the competent experts listed in Table 1-1 of Volume 2, Chapter 1.

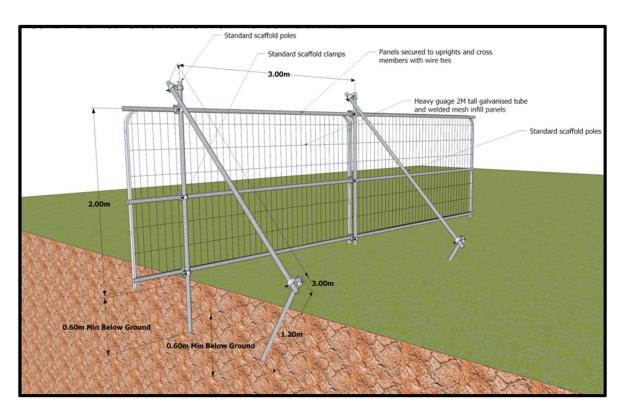
Figure 3 Default specification for tree protection barrier in accordance with BS5837:2012

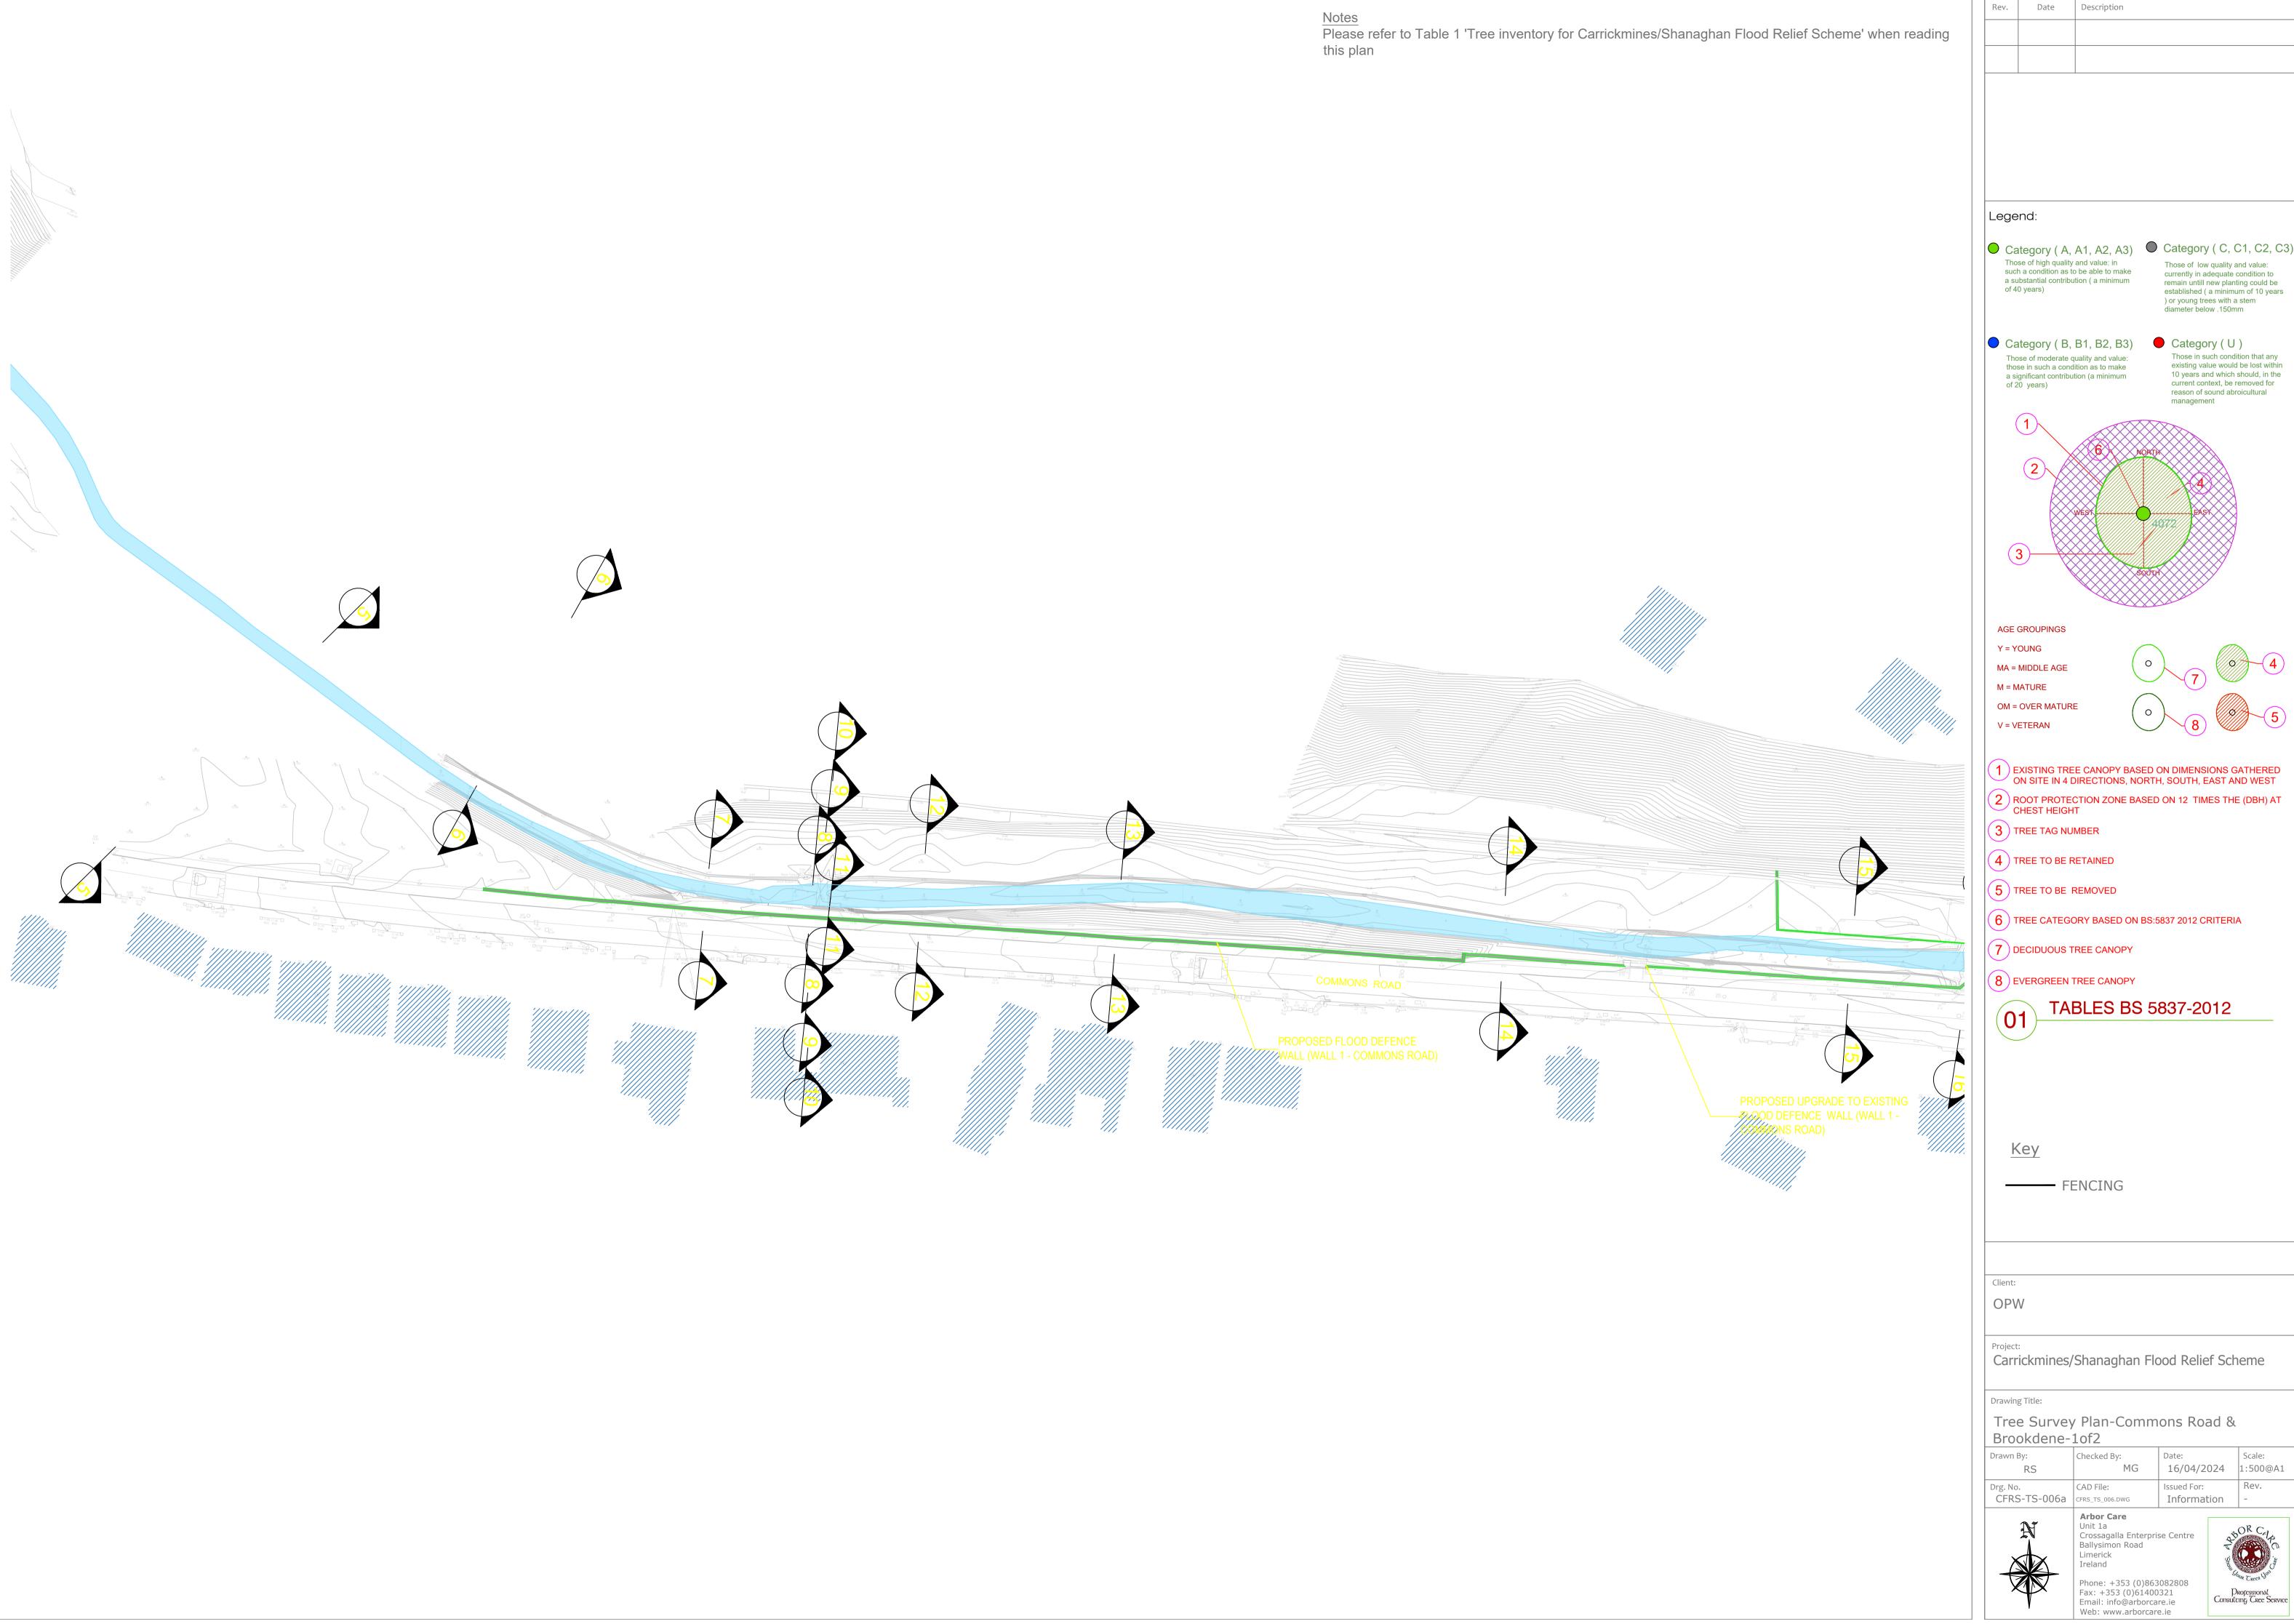
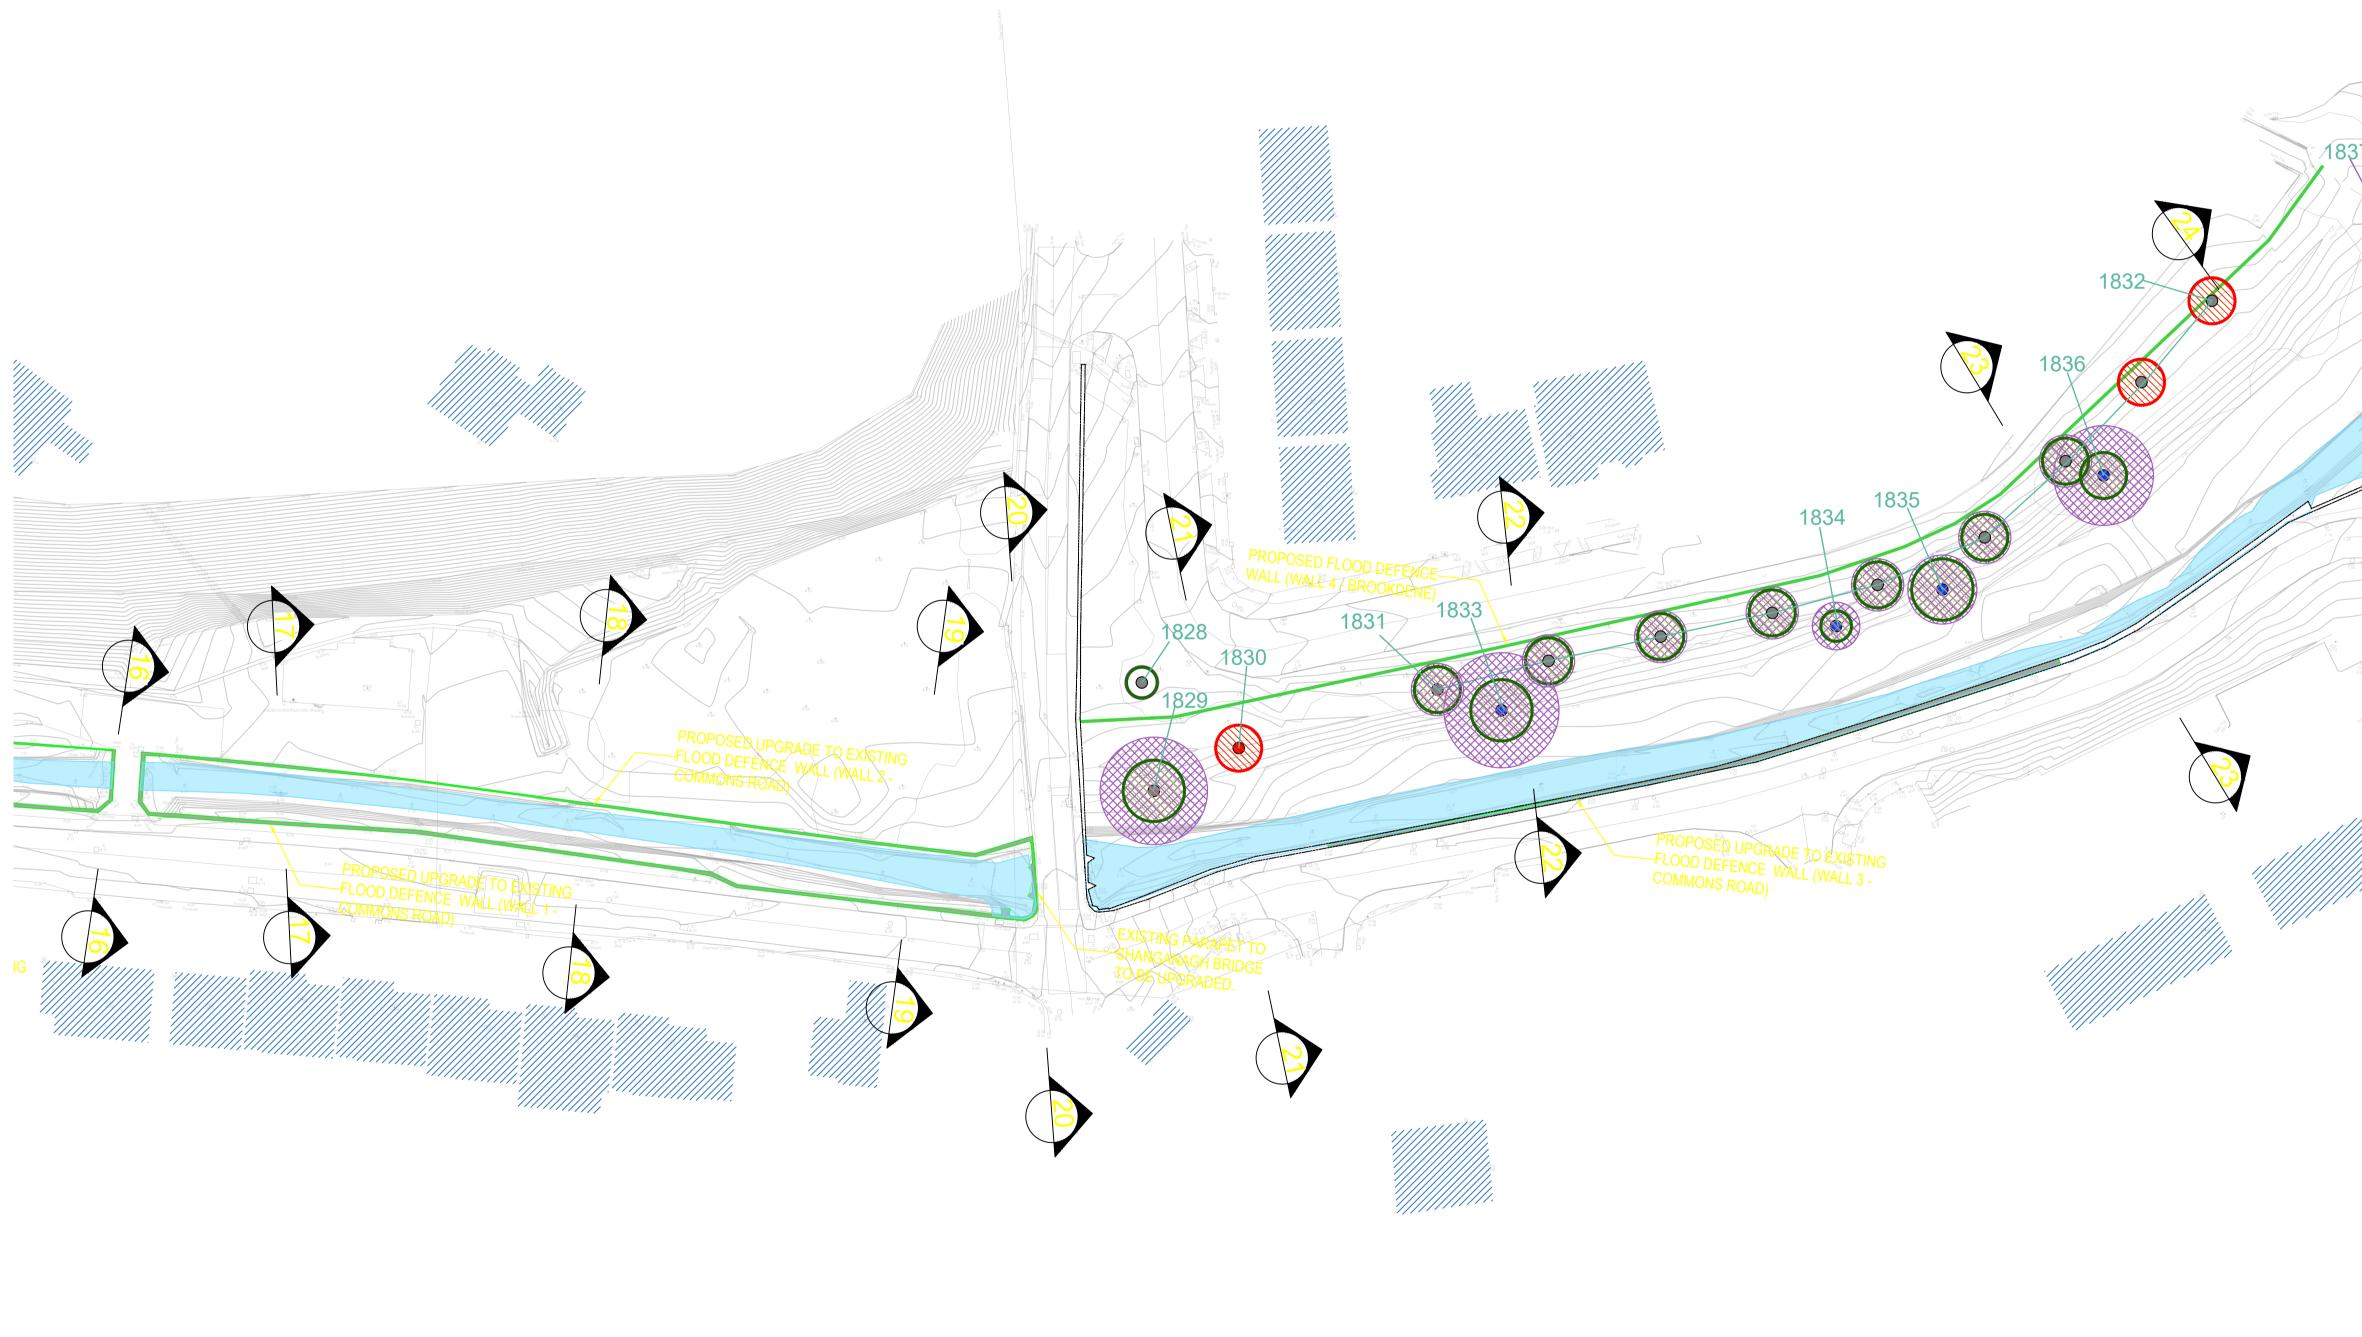
<u>Notes</u> Please refer to Table 1 'Tree inventory for Carrickmines/Shanaghan this plan

1)					
·								
		K	ley					
			FE	ENCING				
		Client:						
		OPV	V					
	F	Project	:					
		Carr	ickmines/	Shanaghan F	lood Relie	ef Sch	ieme	
		Drawing	g Title:					
			e Survey okdene-2	/ Plan-Comr 2of2	nons Roa	ad &		
		Drawn E		Checked By: MG	Date: 16/04/2	024	Scale: 1:500@A1	_
		org. No. CFRS		CAD File: CFRS_TS_006.DWG	Issued For:		Rev.	
			M	Arbor Care Unit 1a			ORCA	_
		×	Â.	Crossagalla Enterp Ballysimon Road Limerick Ireland	orise Centre	s. de	P.C.

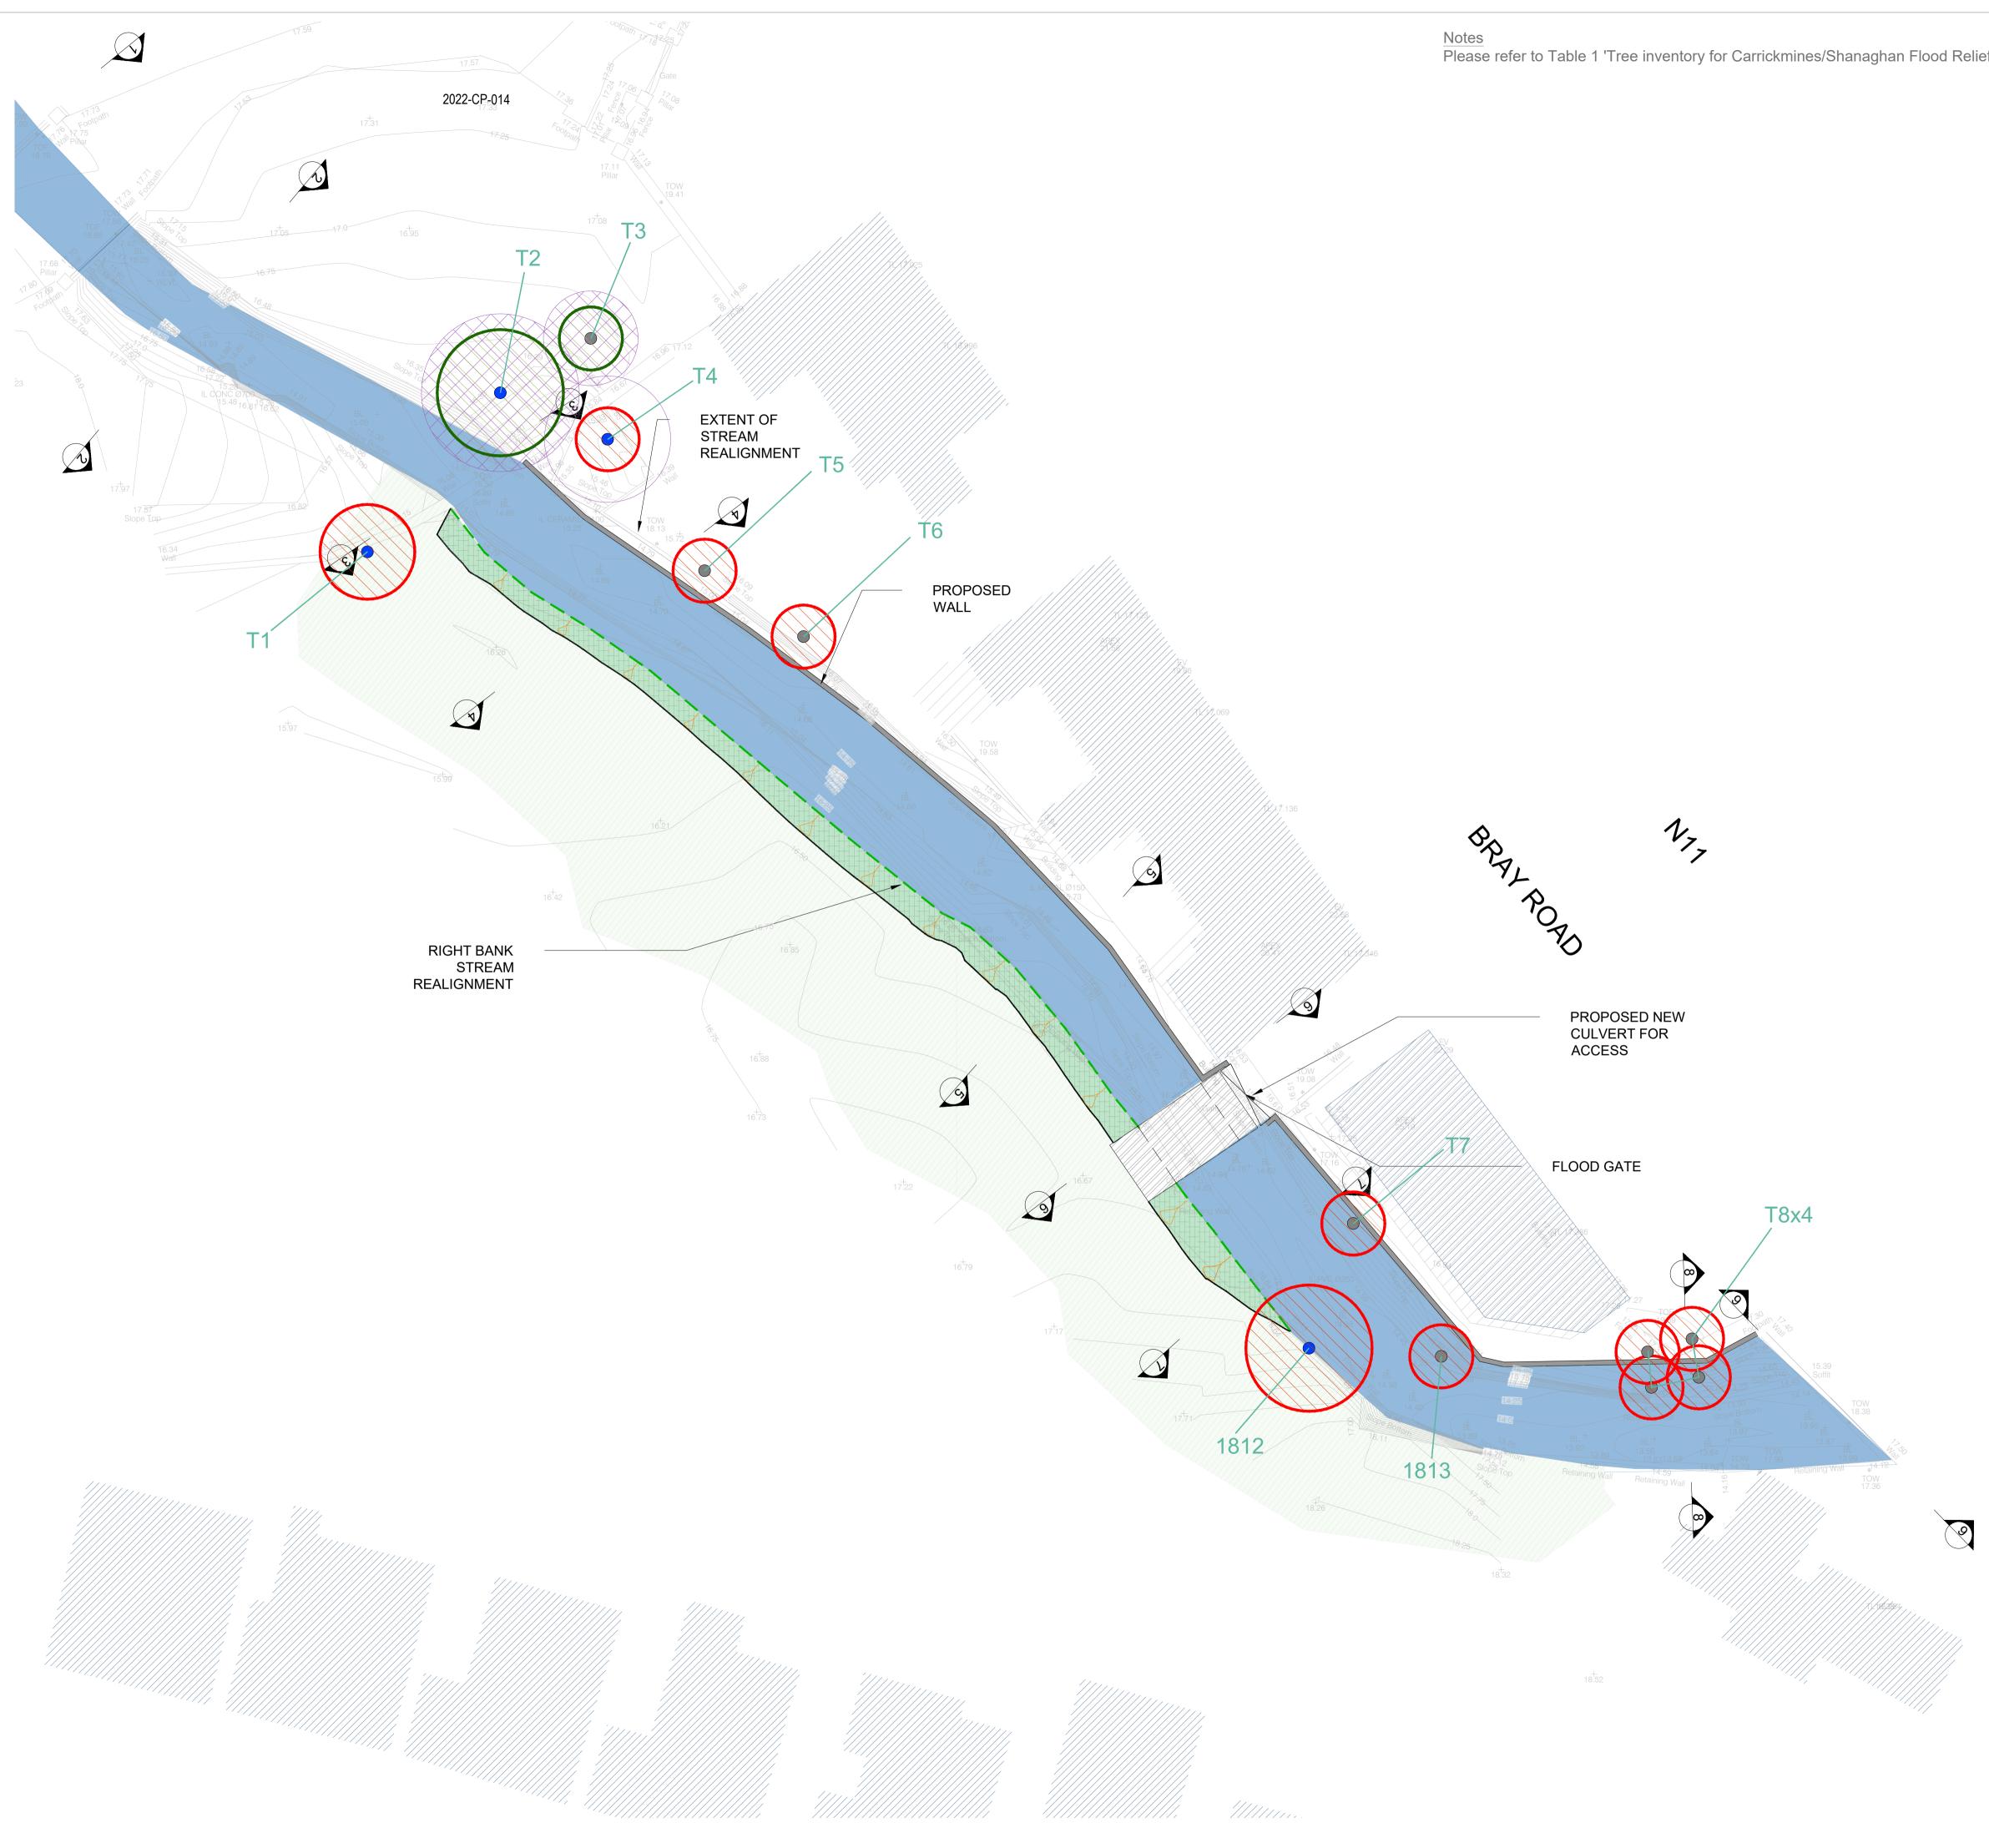
<u>Notes</u> Please refer to Table 1 'Tree inventory for Carrickmines/Shanaghan Flood Relief Scheme' when reading this plan

Drawing Tre	-	Plan-Bray	Road		
Drawn I	<sup>By:</sup> RS	Checked By: MG	Date: 11/12/20	)24	Scale: 1:250@A
Drg. No CF	RS-TS-002	CAD File: cfrs_ts_002.dwg	Issued For: Informat	ion	Rev. 1
	Ň	<b>Arbor Care</b> Unit 1a Crossagalla Enter	prise Centre	~~~~~~~~~~~~~~~~~~~~~~~~~~~~~~~~~~~~~~~	OR Cas
$\times$		Ballysimon Road Limerick Ireland		P. Show	
t		Phone: +353 (0)8 Fax: +353 (0)614	00321		Rofessional Cing Cree Service
	V	Email: info@arbor Web: www.arbor	care.ie	Consul	ting Cree Servi

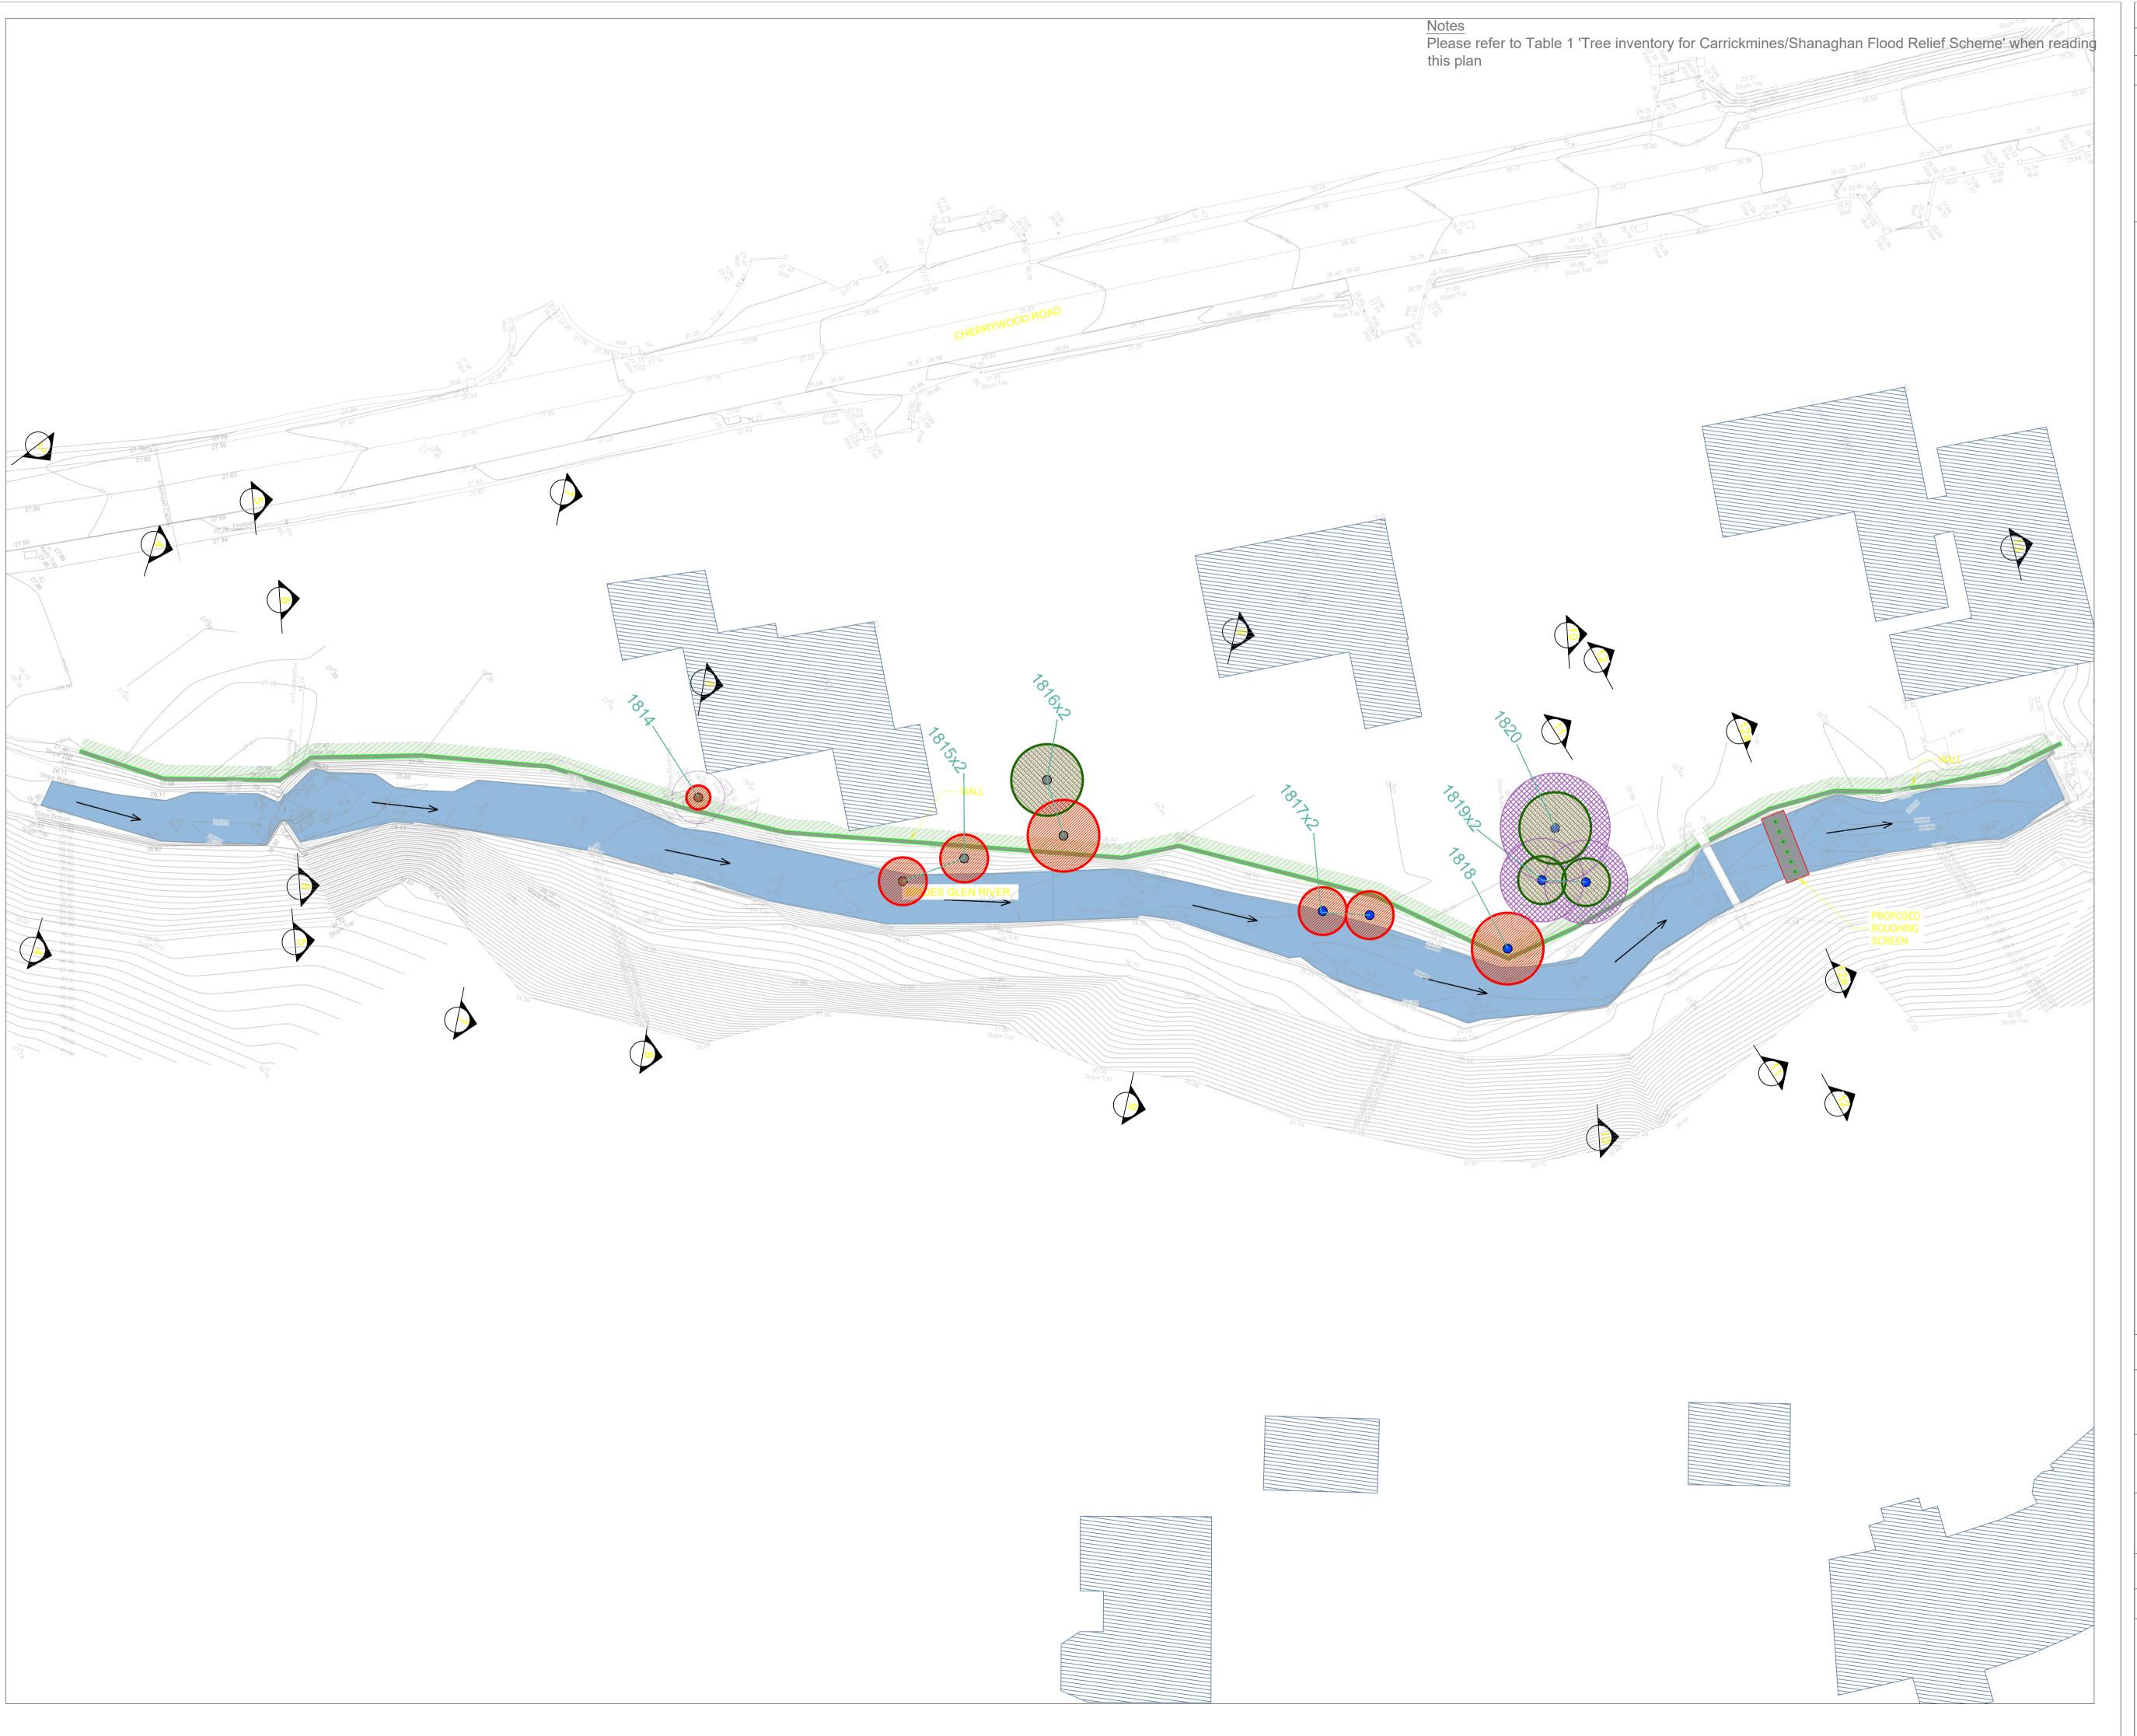
Drawing	Title:				
Tree Road		y Plan-Hero	ns Ghyll-	Cheri	rywood
Drawn By		Checked By: MG	Date: 16/04/2	.024	Scale: L:250@A1
Drg. No.	.S-TS-003	CAD File:	ISSUED For: Informa		Rev.
	Ň	Arbor Care Unit 1a Crossagalla Enter Ballysimon Road Limerick		230	DR C-4.
		Ireland Phone: +353 (0)8	363082808	Show yos	TREES YOU
X	¥×	Fax: +353 (0)614 Email: info@arbor Web: www.arbor	400321 rcare.ie	Dro Consultit	ofessional ng Tree Servic

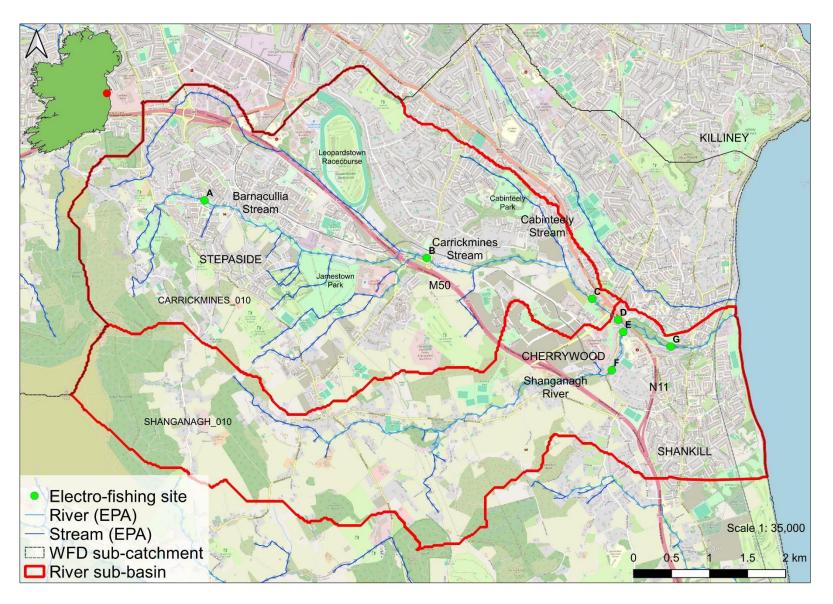
Figure 2.1 Overview of the *n*=7 electro-fishing & fisheries appraisal survey site locations for the proposed Carrickmines Shanganagh River FRS

Triturus Environmental Ltd. were commissioned by JBA to undertake a baseline fisheries assessment of riverine watercourses in the vicinity of the proposed Carrickmines Shanganagh River Flood Relief Scheme (FRS) located near Carrickmines in Dún Laoghaire-Rathdown, Co. Dublin (**Figure 2.1**).

Works areas for the proposed Carrickmines Shanganagh River FRS are located adjacent to several watercourses, namely the Barnacullia Stream, Carrickmines Stream and Shanganagh River (**Table 2.1**; **Figure 2.1**).

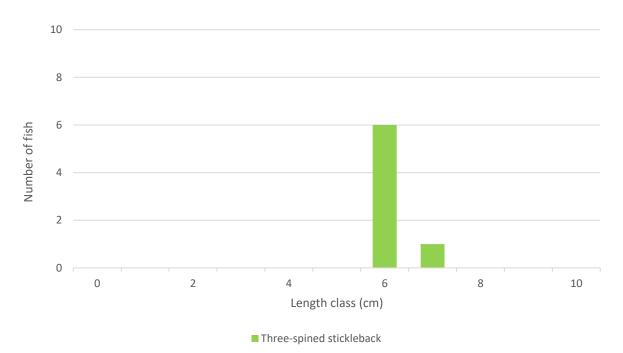
**Figure 4.1** Length frequency distribution recorded via electro-fishing at A on the Barnacullia Stream, August 2023

Three-spined stickleback (*Gasterosteus aculeatus*) (*n*=7) were the only fish species recorded via electro-fishing at site A (**Figure 4.1**). With the exception of stickleback, the site was of poor fisheries value. The stream at this location was too small, shallow and upland to support salmonid populations and none were recorded. Siltation and enrichment pressures also limited the stream's capacity to support salmonid fish. The high energy site was unsuitable for lamprey. While there was some moderate quality habitat for European eel, significant downstream barriers prevent access to the low order, upper reaches of the Carrickmines catchment.

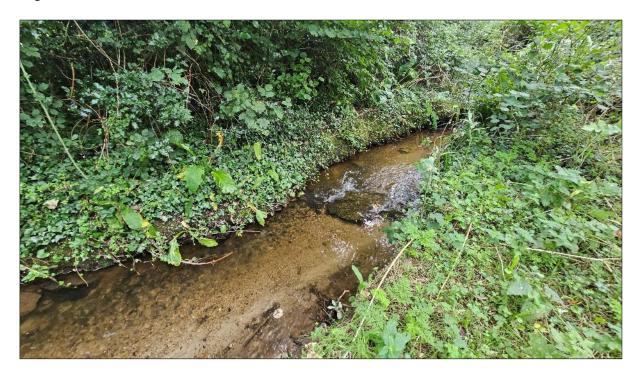
Plate 4.1 Representative image of the Barnacullia Stream at site A, August 2023

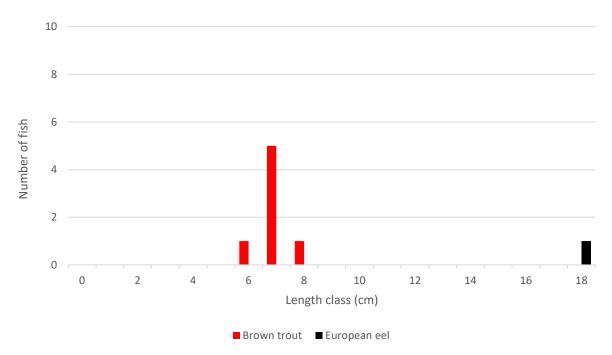
**Figure 4.2** Length frequency distribution recorded via electro-fishing at B on the Carrickmines Stream, August 2023

Brown trout (*Salmo trutta*) (*n*=7) and European eel (*Anguilla anguilla*) (*n*=1) were the only fish species recorded via electro-fishing at site B (**Figure 4.2**). The site was considered a moderate quality salmonid nursery given strong flows with broken flow patterns and a stoney bed. Mixed gravels in deeper pool and glide provided some moderate quality salmonid spawning habitat. However, the nursery and spawning value was reduced due to evident siltation and enrichment pressures. Holding areas for adult trout were present but only juveniles were recorded. Despite significant barriers downstream, a single European eel was captured and the stream offered moderate quality eel habitat (shaded channel with deeper pool and glide with rocky refugia). The stream at this location was of too high an energy to support lamprey spawning or nursery habitats (none recorded).

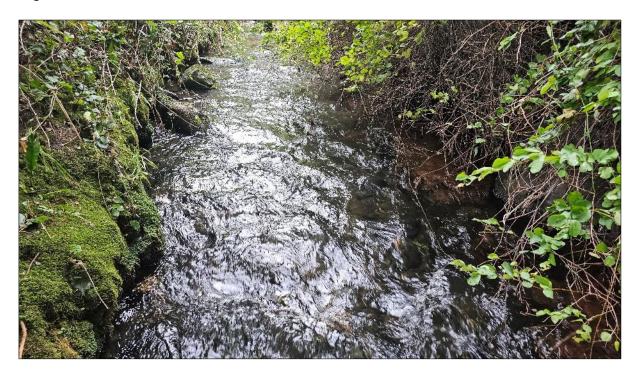
Plate 4.3 Representative image of site B on the Carrickmines Stream, August 2023

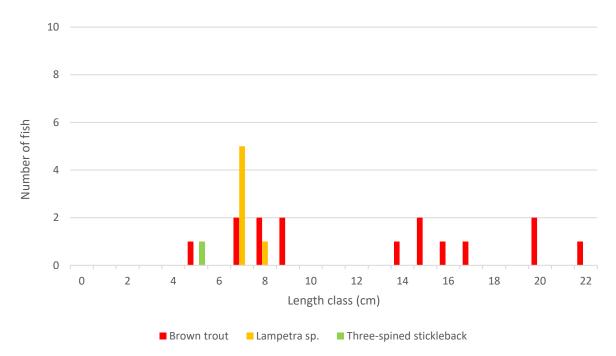
**Figure 4.3** Length frequency distribution recorded via electro-fishing at C on the Carrickmines Stream, August 2023

Brown trout (n=15), lamprey (*Lampetra* sp.) (n=6) and three-spined stickleback (n=1) were recorded via electro-fishing at site B (**Figure 4.3**). The site was a moderate quality salmonid nursery given broken flow patterns and a stoney bed. The nursery value was reduced as a result of evident siltation and enrichment pressures but nonetheless the supported a moderate density of 0+ and 1+ trout. The quality of salmonid spawning habitat was moderate given the presence of mixed gravels in deeper pool and glide. However, the spawning habitat was compromised due to siltation and compaction. Good quality holding areas for adult salmonids were present locally. Despite good suitability, no European eel were recorded. The site was a moderate quality lamprey habitat with finer gravel areas that provided spawning and soft organic rich silt beds that supported a low density of ammocoetes (4 per m<sup>2</sup>; **Table 3.2**). The compacted nature of much of the soft sediment and locally anoxic (black) silt reduced the quality of the nursery habitat accounting for the lower ammocoete density.

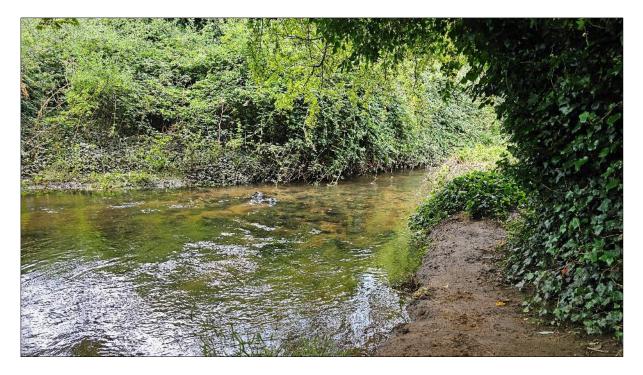
Plate 4.6 Representative image of site C on the Carrickmines Stream, August 2023

area where riffle and glide sequences and pools in undercut banks were present. The substrata were dominated by silt and sand with occasional scattered small boulder and cobble with clusters of mixed coarse gravels. These were heavily compacted with high siltation. The site was too shaded to support macrophytes and none were recorded. However, instream boulders supported *Rhynchostegium riparioides* and *Fontinalis antipyretica* (both rare). The riparian zone supported treelines of mature crack willow, grey willow, sycamore and ash with dense bramble scrub. The site was bordered by scattered trees and parkland (WD5).

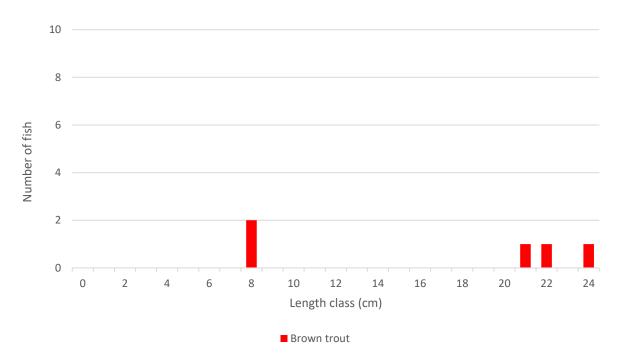
**Figure 4.4** Length frequency distribution recorded via electro-fishing at D on the Carrickmines Stream, August 2023

Brown trout (*n*=5) was the only fish species recorded via electro-fishing at site D (**Figure 4.4**). The site was a poor quality salmonid nursery given the highly modified nature of the channel, enrichment and siltation pressures and the absence of riffle areas. This was reflected by the low abundance of 0+ trout. The quality of salmonid spawning habitat was poor with no evident suitable areas given the rubble strewn bed and high siltation. Good quality holding areas for adult salmonids were however present locally although only a low number of trout were recorded. Despite some moderate suitability (i.e. deeper pool and glide with large coarse substrata refugia), no European eel were recorded. The site was a poor quality lamprey habitat due to the high energy of the channel and absence of spawning or suitable nursery areas (none recorded).

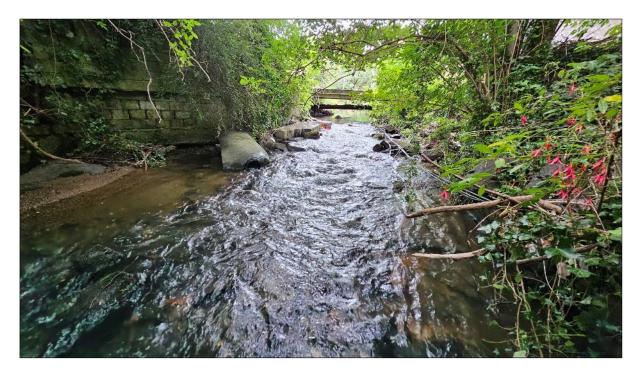
Plate 4.9 Representative image of site D on the Carrickmines Stream, August 2023

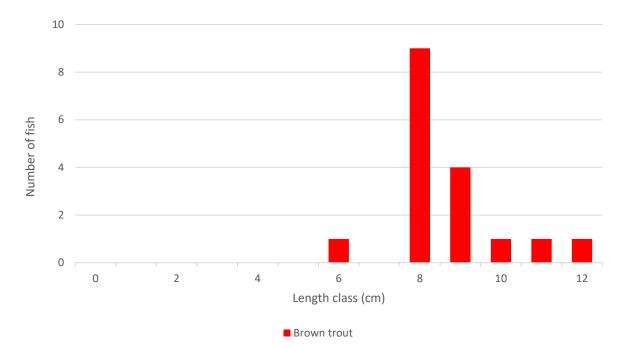
**Figure 4.5** Length frequency distribution recorded via electro-fishing at E on the Shanganagh River, August 2023

Brown trout (*n*=17) was the only fish species recorded via electro-fishing at site E (**Figure 4.5**). The site was a moderate quality salmonid nursery given broken flow patterns and a stoney bed. The nursery value was reduced due to evident siltation and enrichment pressures but nonetheless supported by a moderate density of 0+ and 1+ trout. The quality of salmonid spawning habitat was poor to moderate given limited unbedded mixed gravels and no flow refugia. The site was of low value as a holding habitat for adult salmonids (paucity of pool) with no 2+ fish recorded. Despite some moderate suitability, no European eel were recorded. A significant barrier in the N11 culvert downstream with falls of over 2m may explain the absence of eel. The site was a poor quality lamprey habitat due to the high energy of the channel and absence of spawning or suitable nursery areas (none recorded).

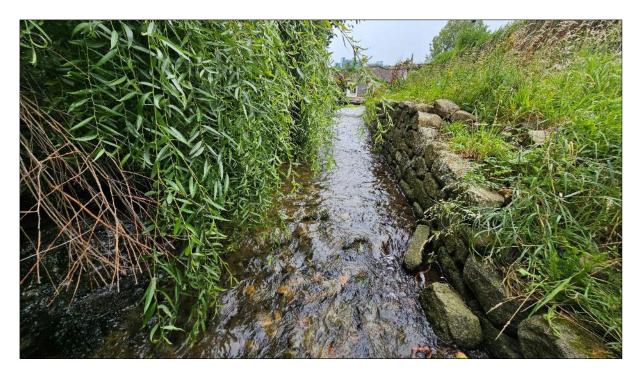
Plate 4.10 Representative image of site E on the Shanganagh River, August 2023

Site E was located on the Shanganagh River (10S01) immediately upstream of the N11 road culverts. The upland eroding spate channel (FW1) had been historically realigned and deepened although retained a semi-natural character. The fast-flowing river was 4m wide and between 0.2-0.3m deep with banks of 4-5m in height. The profile was dominated by riffle and glide sequences with highly localised pool. The substrata were dominated by abundant small boulder and cobble with mixed coarse gravels that were heavily bedded. Siltation was moderate but reduced only due to high flow rates. The high energy site dd not support macrophytes although small boulder supported occasional aquatic bryophytes *Riccardia chamedryfolia* and *Rhynchostegium riparioides*. The muddy banks near the waterline supported the liverwort *Conocephalum conicum* locally. The riparian zone of the south bank supported mature ash, hazel (*Corylus avellana*) and ornamental Leyland cypress (*Cupressus × leylandii*) and weeping willow (*Salix babylonica*). The north bank supported dense scrub vegetation including hedge bindweed, bramble, buddleia and invasive Japanese knotweed (*Reynoutria japonica*) immediately upstream of the road culvert. The site was bordered primarily by buildings and artificial surfaces (BL3).

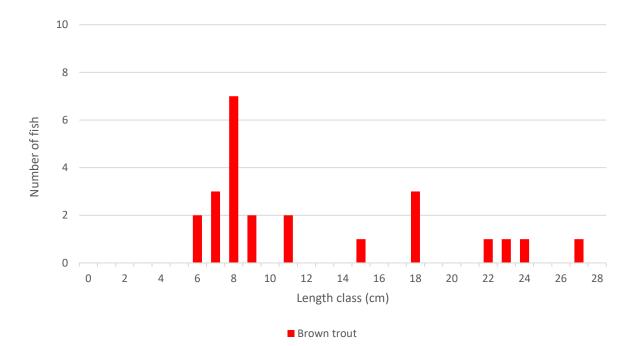
Brown trout (*n*=24) was the only fish species recorded via electro-fishing at site E (**Figure 4.5**). The site supported the highest density of salmonids recorded during the survey. The river at this location was a good quality salmonid nursery given broken flow patterns and a stoney bed with good densities of juvenile trout present. Mixed clean gravels in deeper pool and glide provided good quality salmonid spawning habitat. Frequent deep pool were of high value as adult salmonid holding areas. While European eel habitat was considered of moderate quality, significant barriers downstream likely explain the absence of the species. The site was a poor quality lamprey habitat due to the high energy of the channel and absence of suitable nursery areas (none recorded).

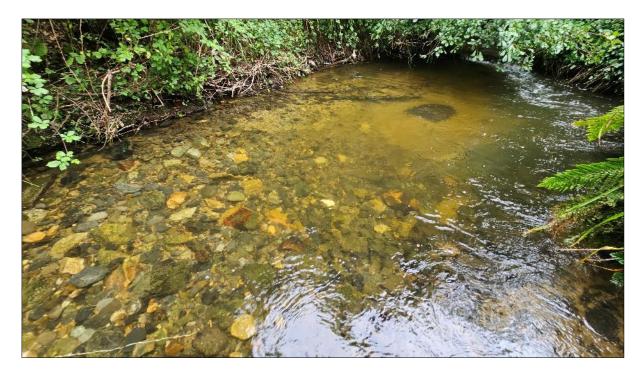
Plate 4.12 Representative image of site F on the Shanganagh River, August 2023

Site F was located on the Shanganagh River (10S01) downstream of the Mullinastall Road crossing, approximately 0.5km upstream of site E. The fast-flowing semi-natural upland eroding spate channel (FW1) was 5-6m wide and 0.2-0.8m deep, with a naturally incised valley (up to 3m high banks) on the east bank. The profile comprised regular repeating sequences of pool, riffle and glide. The substrata were dominated by abundant cobble scattered small boulder with cobble, mixed coarse gravels and sand. The bed, while somewhat compacted given high flow rates, had light siltation. The high energy and shaded site did not support macrophytes. However small instream boulders supported frequent *Rhynchostegium riparioides* and occasional *Fontinalis antipyretica*. The muddy banks near the waterline supported *Conocephalum conicum*. The river was lined with mature treelines/woodland supporting wych elm (*Ulmus glabra*), beech (*Fagus sylvatica*) and holly with bramble and ivy. The site was bordered by mixed broadleaved woodland (WD1) and lawns (GA2) associated with detached properties.

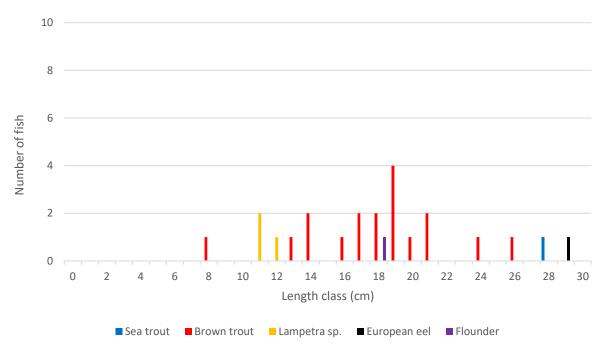
**Figure 4.7** Length frequency distribution recorded via electro-fishing at G on the Shanganagh River, August 2023

Sea trout (Salmo trutta) (*n*=1), brown trout (*n*=18), lamprey (*Lampetra* sp.) (*n*=3), European eel (*n*=1) and flounder (*Platichthys flesus*) (*n*=1) were recorded via electro-fishing at site G (**Figure 4.7**). This was the highest species diversity recorded during the survey. The site was a moderate quality salmonid nursery only given the limited broken glide in the vicinity of the survey area. Spawning habitat was of moderate quality due to the presence of more limited mixed clean gravels with high amounts of sand and silt. Superior spawning and nursery habitat existed upstream of the survey area in the reaches downstream of the N11 culverts. Frequent deeper pool provided good quality holding areas for adult salmonids, inclusive of migratory sea trout (single adult recorded; **Plate 4.15**). The site was of high suitability for European eel (deeper pool and glide with undercut banks and good prey resources) but only a single adult yellow eel was recorded. The site was of moderate value only as a lamprey nursery habitat due to the presence of compacted, sand-dominated soft sediments. These supported a low density of ammocoetes (1.5 per m<sup>2</sup>; **Table 3.2**). Good quality lamprey spawning habitat was present locally.

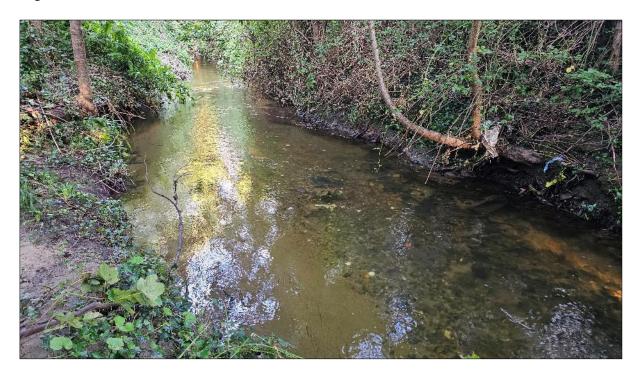
Plate 4.14 Representative image of site G on the Shanganagh River, August 2023

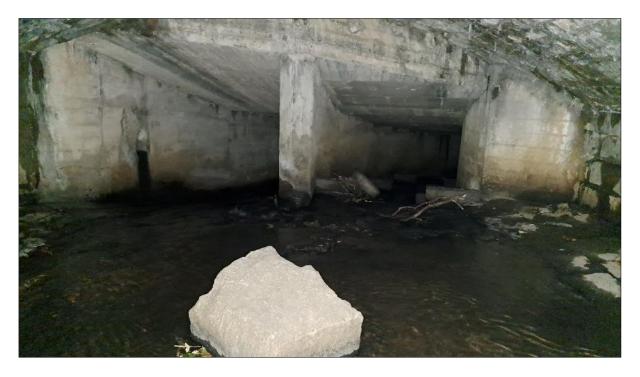
Plate 5.1 Example of a significant barrier to fish passage on the Carrickmines Stream at the N11 road culvert (high gradients under road & >2m fall)

European eel are Red-listed in Ireland (King et al., 2011) and are classed as 'critically endangered' on a global scale (Pike et al., 2020). Despite habitat suitability at all survey sites, eel were only recorded from site B on the upper reaches of the Carrickmines Stream and site G on the lower Shanganagh River (one eel at each site). Whilst eels are known for their remarkable ability to climb and navigate structures as glass eels (Podgorniak et al., 2015), the paucity of Red-listed European eel in the survey watercourses (and wider Dargle\_010 sub-catchment, pers. obs.) is evidently restricted by numerous significant instream barriers and resulting in poor ingress of this migratory fish species into the catchment.
