# Carrickmines-Shanganagh River Flood Relief Scheme EIAR – Volume 3 Appendices

February 2025

This report relates to the Carrickmines-Shanganagh River Flood Relief Scheme commissioned by Dún Laoghaire-Rathdown County Council (DLRCC), on behalf of the Office of Public Works (OPW). Conor O'Neill and Bernadette O'Connell of JBA Consulting compiled this report, which was prepared by the competent experts listed in Table 1-1 of Volume 2, Chapter 1.

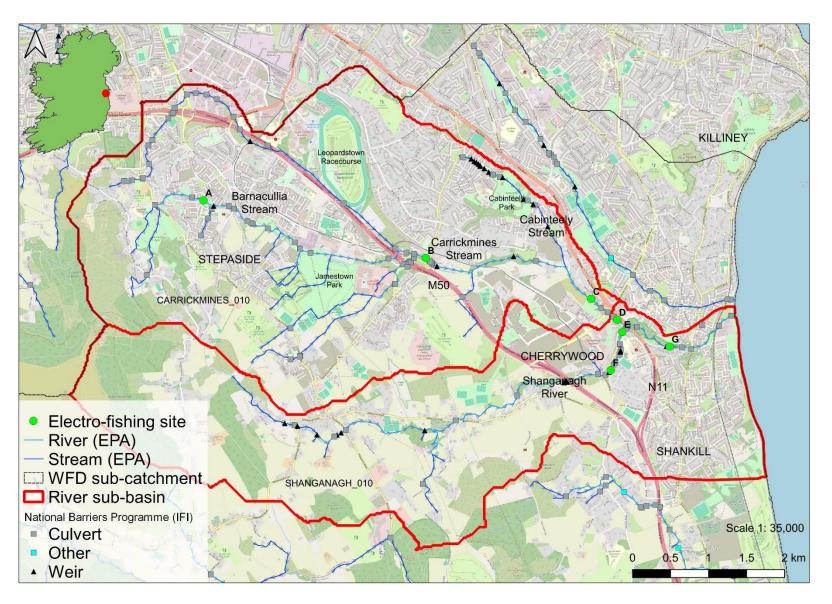
Figure 5.1 Location of instream barriers in vicinity of the proposed Carrickmines Shanganagh River FRS (source: IFI's National Barriers Programme)

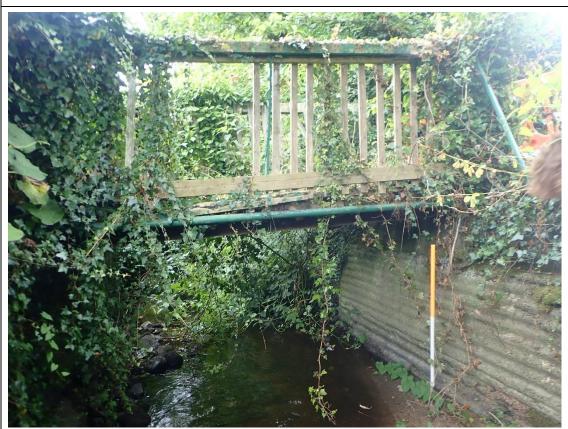
Plate 1: Footbridge is constructed on steel girders and has a light open timberwork parapet. The right bank underneath the bridge has been strengthened by the addition of a concrete pour

A footbridge crosses the river downstream of Waterfall Cottage and is recorded on historic OS mapping since the First Edition 6-inch series *c*. 1840. The footbridge is a simple affair today in poor repair, comprising a light timber parapet supported on two steel girders (Plate 1). The right bank has a poured concrete render that retains the corrugated sheet profile of the formwork used to retain the concrete.

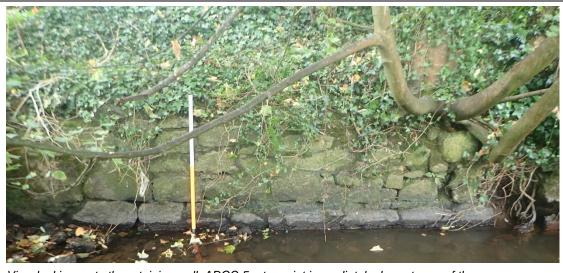
View looking on to the retaining wall, ADCO 5, at a point immediately downstream of the recently insert outfall pipe (main report Plate 17)

The corresponding left bank retains a granite-built stone wall, with clay slippage falling into the channel (Plate 17). Once downstream of the large outfall, a similar stone retaining wall survives on the right bank. The stone walls are not recorded on cultural heritage registers and warrant consideration. Accordingly, they are referred to in this report as ADCO 4 and ADCO 5. The walls are vertical in profile and survive to a height of approximately 800mm. They are made from roughly shaped granite blocks cut into rectangular shape and measuring approximating 350mm wide by 25mm high in size.

A granite-built stone wall, vertical in profile, survives from approximately the modern outfall pipe inserted into the right bank, to ADCO 6; a distance of 10-15m. The wall is made from roughly shaped granite blocks cut into rectangular shape and measuring approximating 350mm wide by 25mm high. The wall survives to approximately 800mm in height

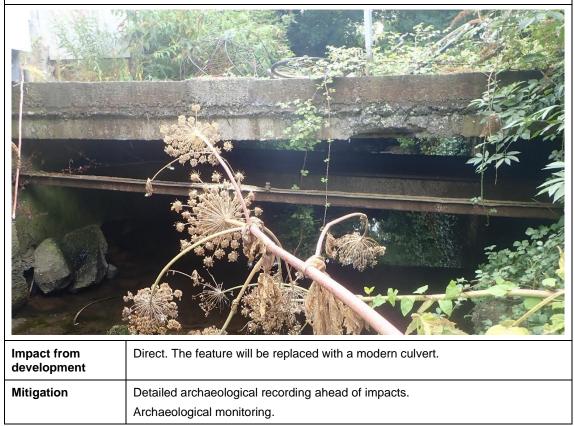
Reference	Site type	Status	ITM Easting	ITM Northing
U121	Footbridge	Replaced	724405	723332

The site of U121 footbridge recorded on the historic OS maps is populated today by a more recent construction, comprising a simple concrete slab surface supported on a series of steel girders

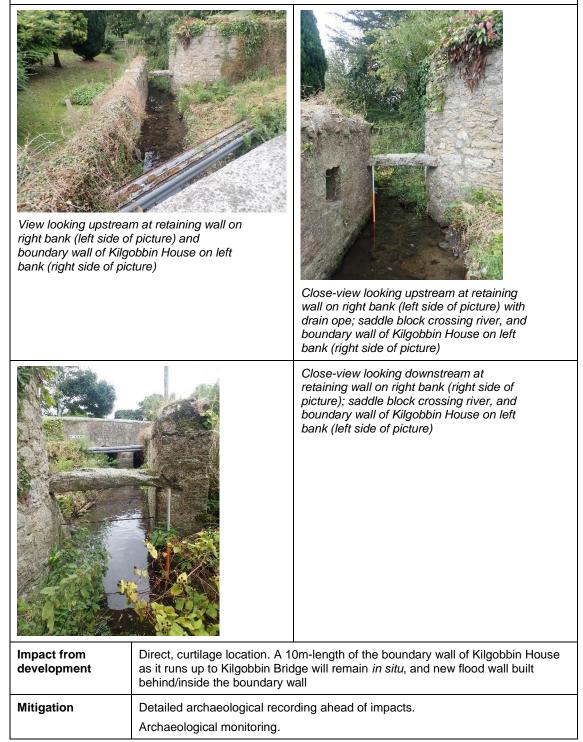
Reference	Site type	Status	ITM Easting	ITM Northing
ADCO 10	Wall	Upstanding	719330	724793

The right bank (south bank) upstream bridge U44 has a stone-built retaining wall (ADCO 10) that includes two drainage opes and a saddle slab that connects to the boundary wall of Kilgobbin House on the left bank. An iron bar located below the saddle slab suggests it may have served as part of a sluice. As a protected structure, it is likely that the boundary wall is of Kilgobbin House is within the curtilage of the protected site and, as such protected status may extend to the saddle slab and, by extension to the stone retaining wall that is ADCO 10.

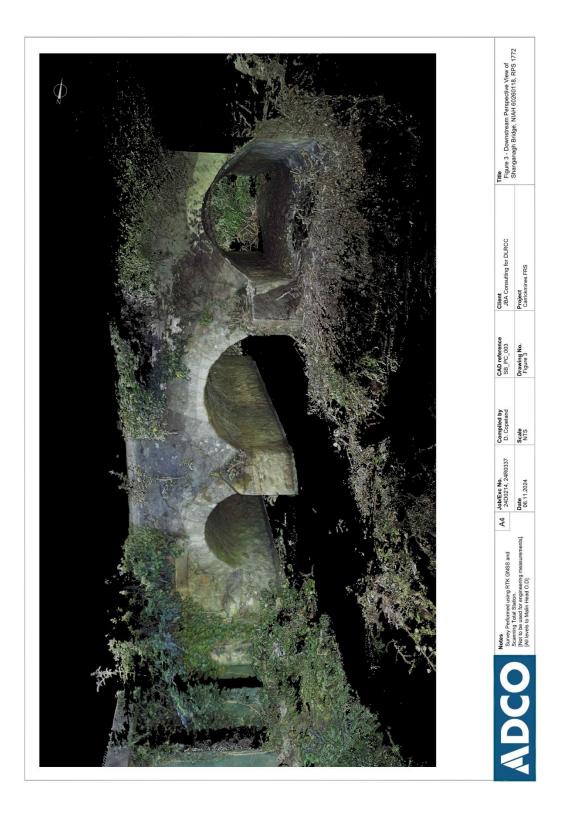
Figure 3: Point Cloud image derived from laser scan survey of Shanganagh Bridge. View looking upstream towards bridge.

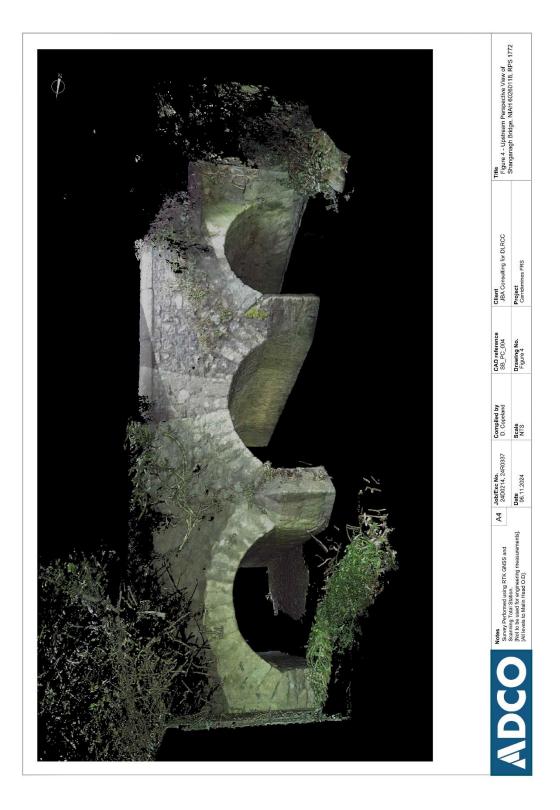
Figure 4: Point Cloud image derived from laser scan survey of Shanganagh Bridge. View looking downstream towards bridge.

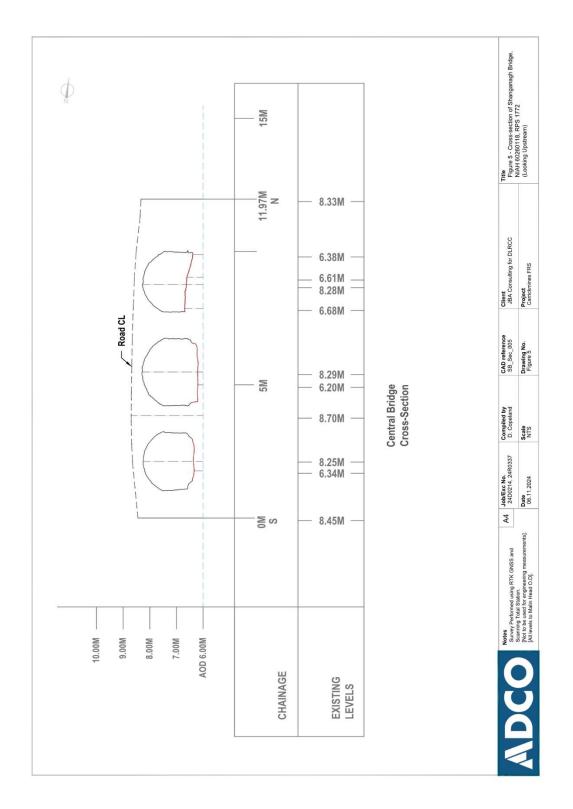
Figure 5: Cross section through Shanganagh Bridge.

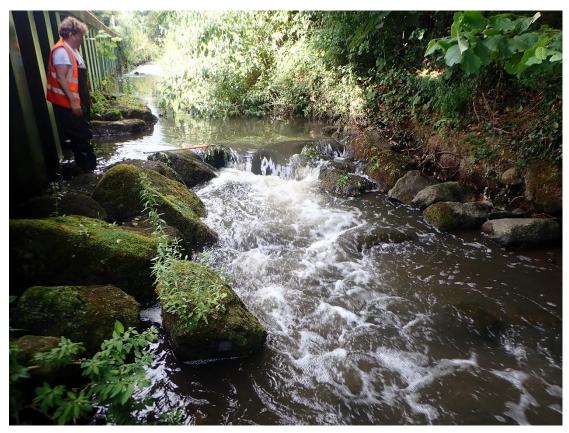
Plate 1: View looking upstream at slight dip in channel bed, perhaps constructed as a fish pass.

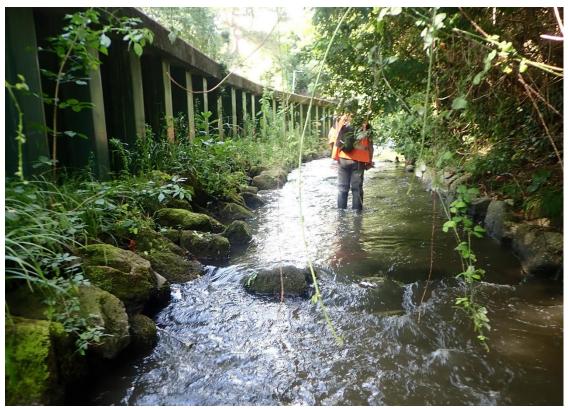
Plate 2: View looking upstream showing Larsen piling and rock armour protection that defines the right bank downstream of Shanganagh Bridge.

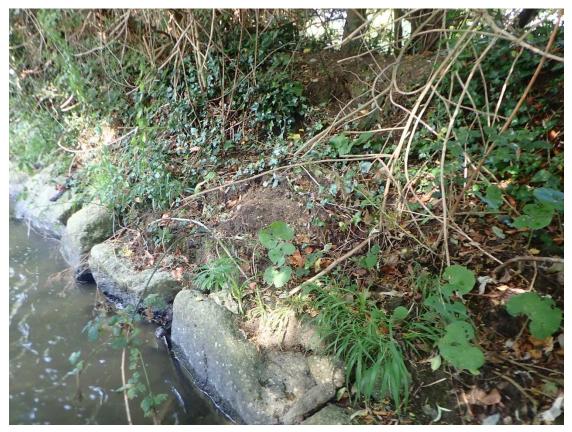
Plate 3: View of left bank showing rock armour protection added to base, downstream of Shanganagh Bridge.

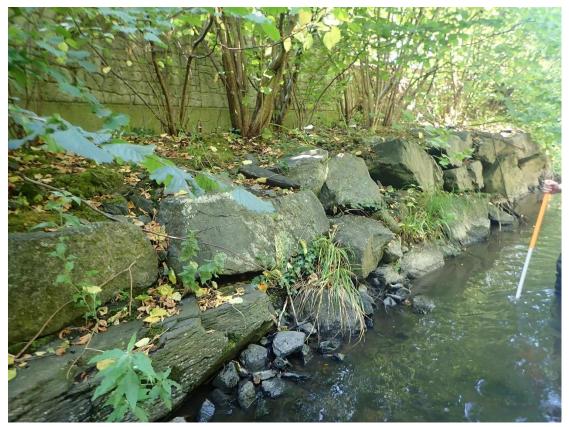
Plate 4: View of right bank above Shanganagh Bridge, showing concrete slab retaining wall and rock armour protection along riverbank.

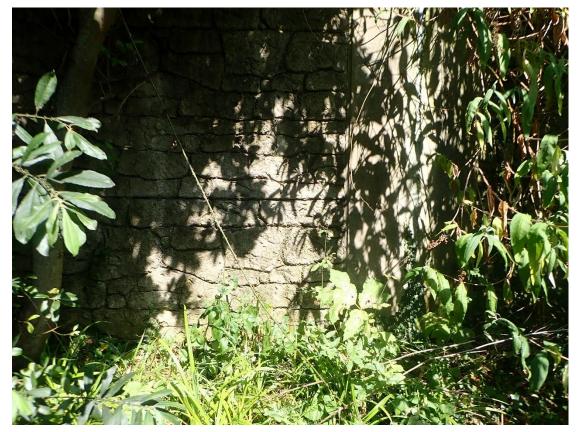
Plate 5: View of concrete slab retaining wall on left bank upstream of Shanganagh Bridge.

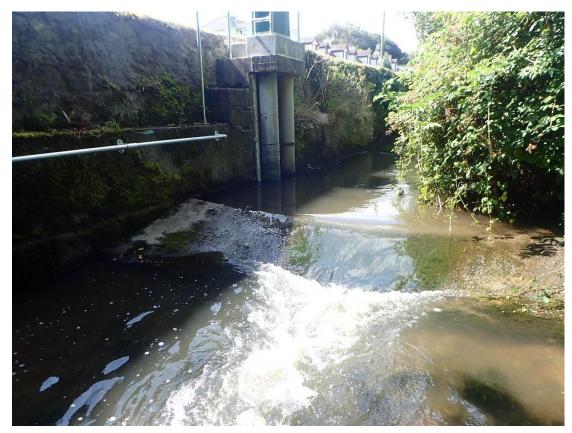
Plate 7: View of concrete weir and flood gauge at upstream limit of UAIA area.

The flood gauge and concrete weir feature mentioned above are located at the upstream limit of the UAIA survey area (Plate 7).

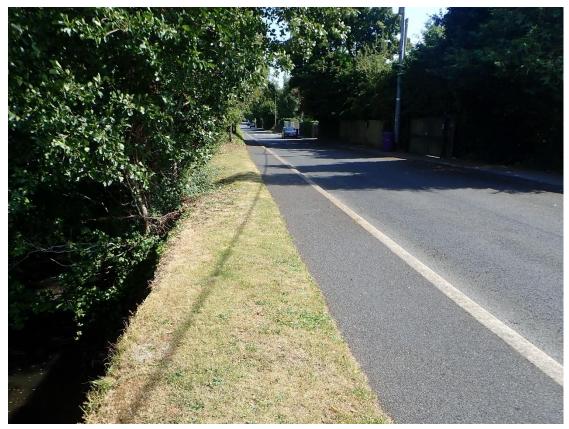
Plate 8: View east along Commons Road, where the top of the stone retaining wall is flush with the road surface that, in turn, serves as an embankment to the lower-lying properties on the other side of the road.

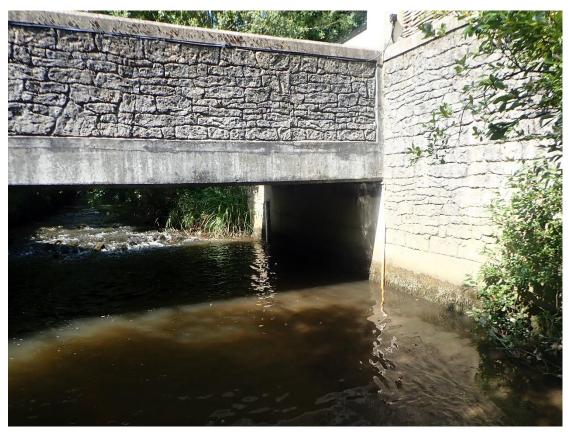
Plate 9: Modern vehicular bridge providing access across the Shanganagh River to a private residence off Commons Road.

reinforced concrete. The riverbanks up- and downstream of the bridge have been altered to accommodate vertical retaining wall panels (Plate 9).

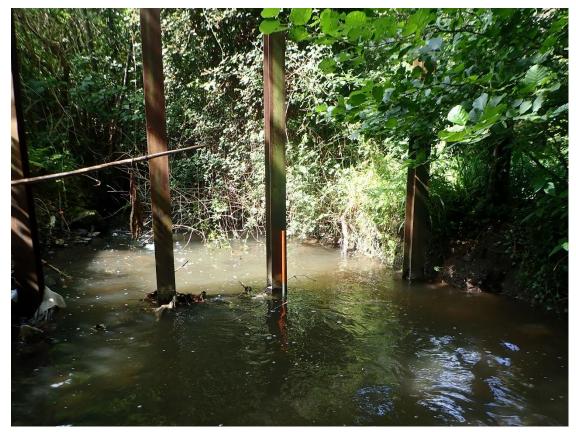
Plate 10: Debris trap inserted into the Shanganagh River in the recent past.

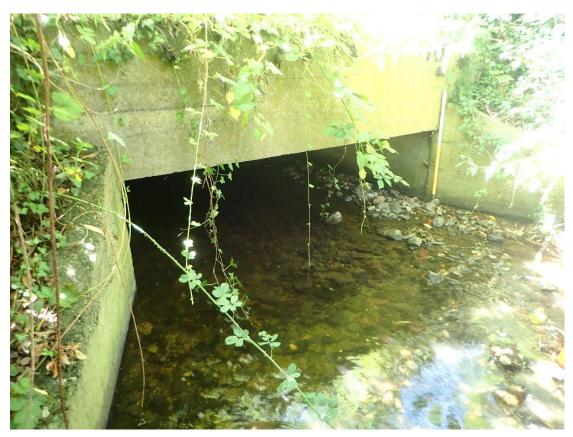
Plate 11: Current exit of the Loughlinstown River South on the east side of the N11 is through a reinforced concrete culvert.

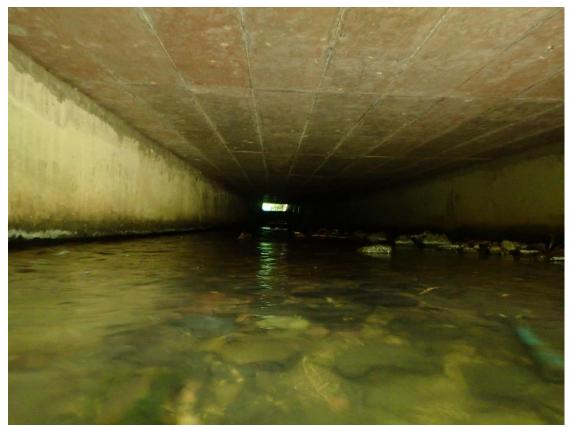
Plate 12: View looking upstream at channel of Loughlinstown River South as it flows under the N11 culvert.

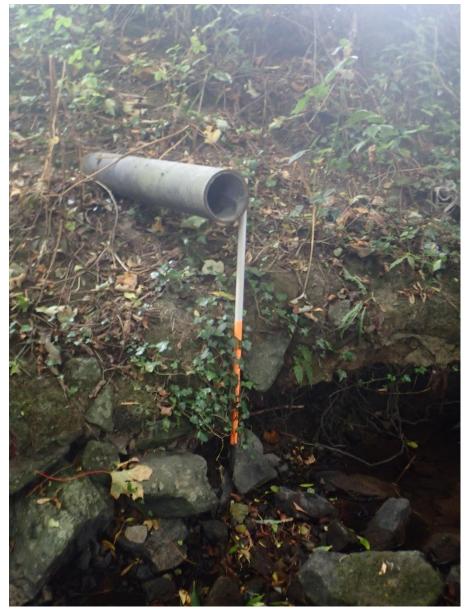
Plate 15: Example of pipe entering Loughlinstown River North from the left bank.

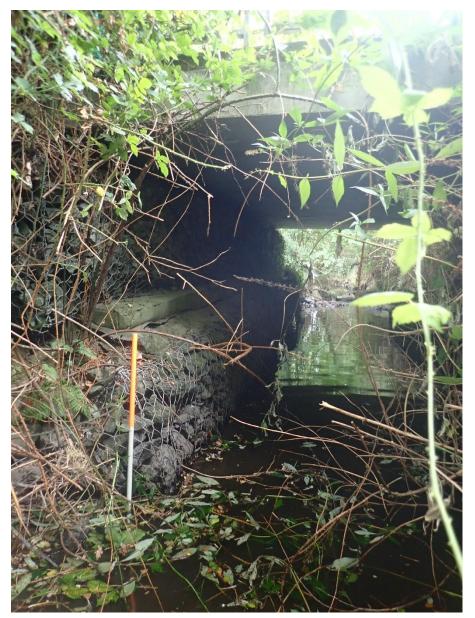
Plate 16: Modern bridge replacing U115, Loughlinstown River North.

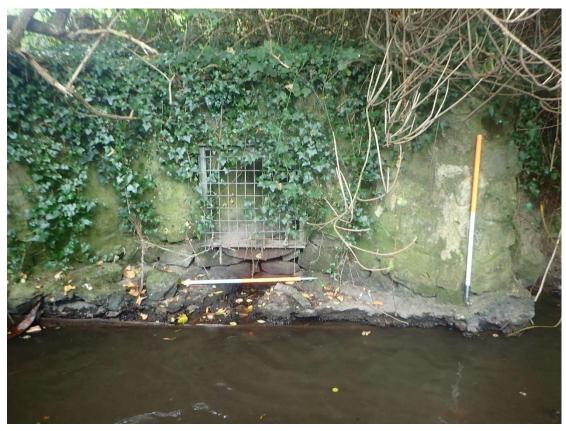
Plate 17: outfall pipe and attendant impacts on right bank, Loughlinstown River North.

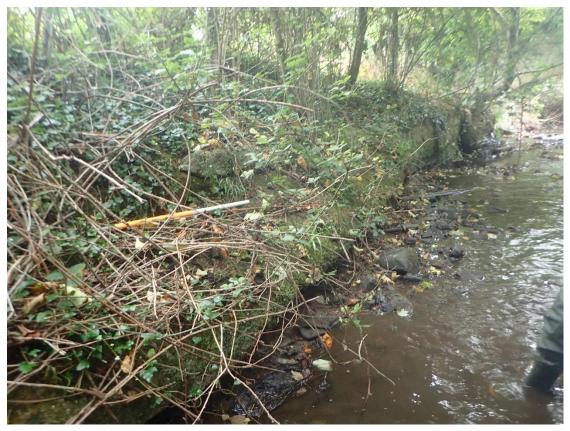
Plate 18: Clay slippage into river channel off left bank with stone retaining wall, ADCO 4, behind the slippage and extending downstream.

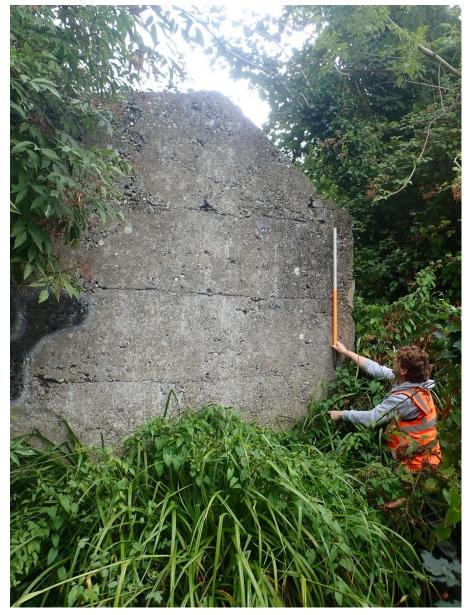
Plate 19: View looking north at rear wall of outhouse that occupies one of the nowcommercial premises on the old Bray Road. The poured concrete-and-pebble temper mix is typical of early 20th-century dwellings in the wider area.

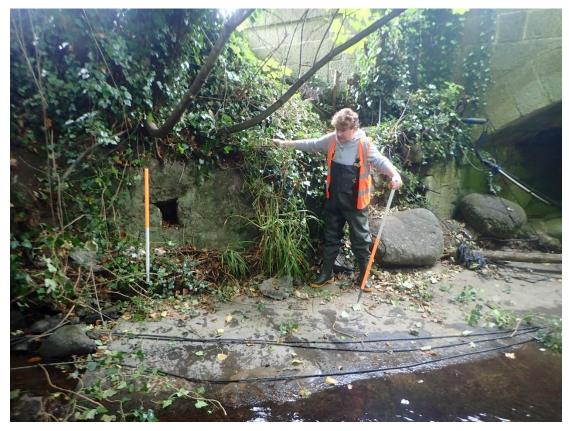
Plate 20: View of retaining wall upstream of and associated with Loughlinstown Bridge, ADCO 9. The riverbed at this point is covered in the stone apron that is also associated with the bridge.

At this point, approaching the old Bray Road, the riverbed has a stone-built apron set across it. The upstream element of the apron has a thin concrete skin added later but the main part is fully of stone work, comprising large cut granite blocks set in line with along the water flow. The stones in general measure 430mm long by 170mm wide and are set in profile to follow a shallow shelving dip with the lowest part in the central channel (Plate 20). The apron serves as a protective anti-scour device to the bridge that carries the old Bray Road and should be regarded as an integral part of the bridge. Named 'Loughlinstown Bridge' on the OS First Edition map (*c*. 1840), it is not previously recorded as a cultural heritage asset and is recorded here as ADCO 9.

The upstream approach to Loughlinstown Bridge includes a retaining wall on the left bank and a stone-built apron set across the channel bed that continues in under the bridge (main report Plate 20). These two elements are considered as features directly associated with the bridge. The wall is approximately 1.2m high and includes a culverted stone drain outlet. The upstream element of the apron has a thin concrete skin added later but the main part is fully of stone work, comprising large cut granite blocks set in line with along the water flow. The stones in general measure 430mm long by 170mm wide and are set in profile to follow a shallow shelving dip with the lowest part in the central channel. The apron serves as a protective anti-scour device to the bridge that carries the old Bray Road.

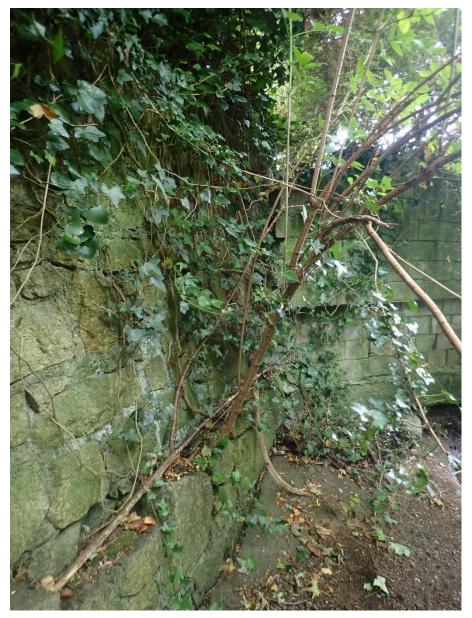
Plate 21: Expanse of breeze blocks to the right that replace stone wall to the left (ADCO 7), where the stone wall has collapsed or been removed.

The right bank downstream of the arch ADCO 6 continues the retaining wall seen upstream (ADCO 5) and is 500mm in height, ADCO 7. It is fractured in places, and obscured by vegetation in other places. Downstream of U121, a stretch of stone wall is replaced with breeze-blocks (Main report Plate 21). The breeze-block section is built directly against the original wall, which is 2m high at this point. An area of collapse reveals the construction of ADCO 7, showing the natural clay bank that was cut into to permit the building of a battered wall with a stone rubble core measuring 600mm in depth. The battered façade stands on a stone plinth that extends a further 100mm out from the façade and stands 800m high above the riverbed. A *c.* 15m-long section of the stone wall has collapsed as the wall follows the bend of the river channel.

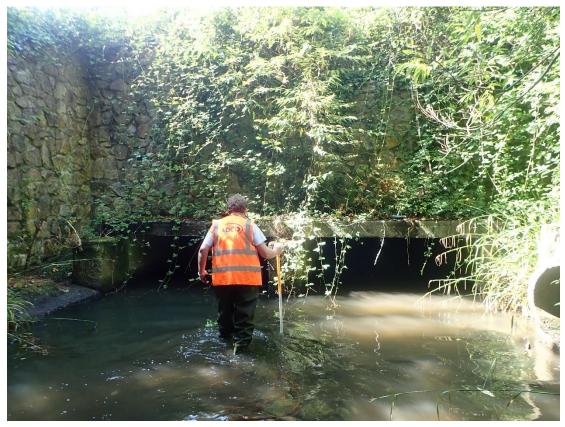
Plate 22: Current exit of the Loughlinstown River North on the east side of the N11 is through a reinforced concrete culvert.

Construction of the N11 significantly widened the road area, extending it eastwards. The opening of the Loughlinstown River North on the east side of the N11 today is by means of a modern concrete culvert (Plate 22).

Construction of the N11 significantly widened the road area, extending it eastwards. The opening of the Loughlinstown River North on the east side of the N11 today is by means of a modern concrete culvert (main report Plate 22).

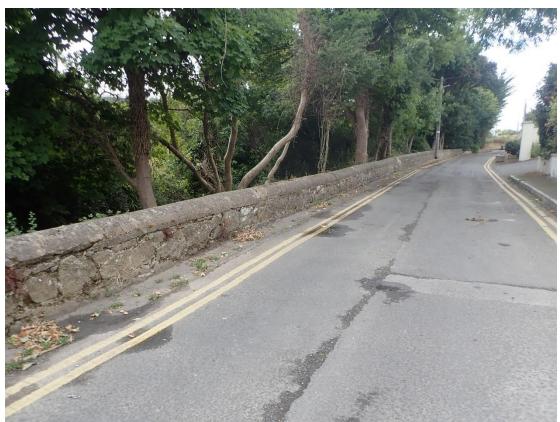
Plate 23: View looking west along road at parapet wall that ovrlooks Carrickmines River.

The opposite side of the road next to the river channel has a low stone wall (Plate 23). The river bank is earthen and overgrown. The other bank is constructed. Both banks are heavily overgrown.

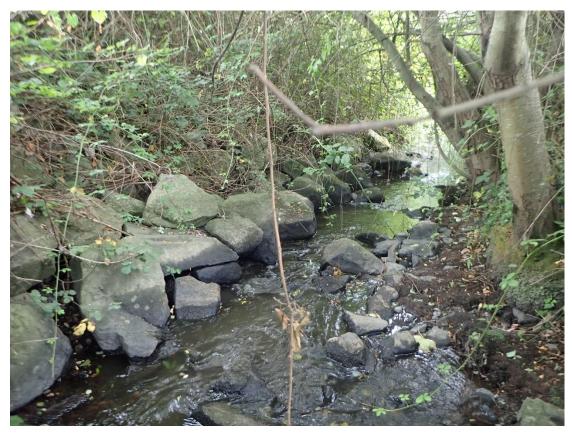
Plate 24: View looking downstream (east) along Carrickmines River, with rock armour boulder inserted at base of riverbank.

The riverbed is flat and narrow, measuring some 2m in width and with a gravel bed. Rock armour protection has been added along its length (Plate 24). The channel widens slightly approaching the roadbridge at Glenamuck Roundabout. While historic OS maps record a pre-existing bridge in this location, as 'Carrickmines Bridge', there is no record of the structure available. The current

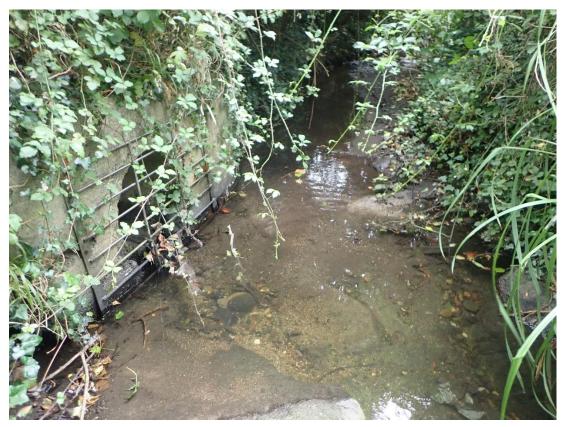
Plate 27: View of outfall pipe that flushes into Kilgobbin Stream in Belarmine Park.

The section of Kilgobbin Stream in Belarmine Park is a location where the stream channel meanders. An outfall pipe is located here, and the stream has been culverted as it flows downstream from there (Plates 27–28). A small extent of stonework is evident beneath a concrete slab feature, and is the only indication of earlier activity at this location (Plate 29). It has not been recorded as a heritage feature in this report.

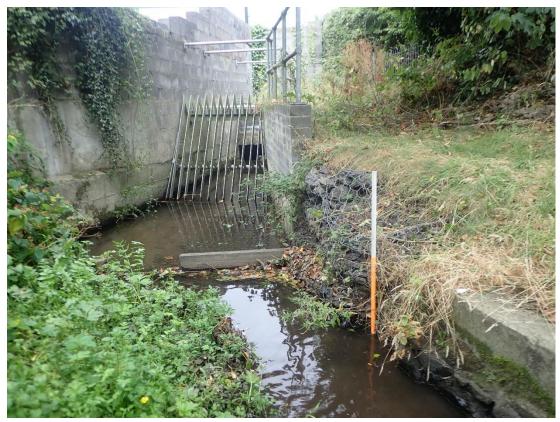
Plate 28: View of Kilgobbin Stream in Belarmine Park where it is culverted.

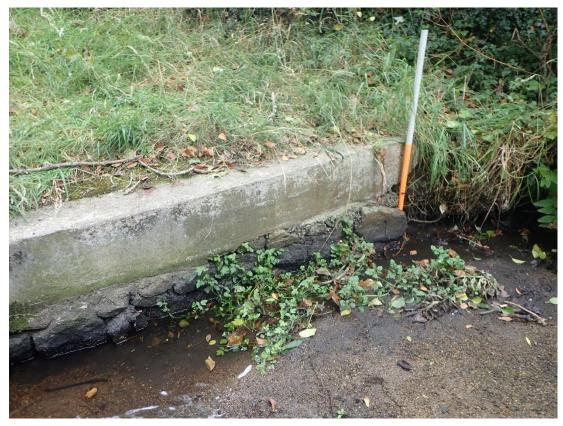
Plate 29: View of stone setting at base of streambank in Belarmine Park, where a modern reinforced concrete feature has been placed above it.

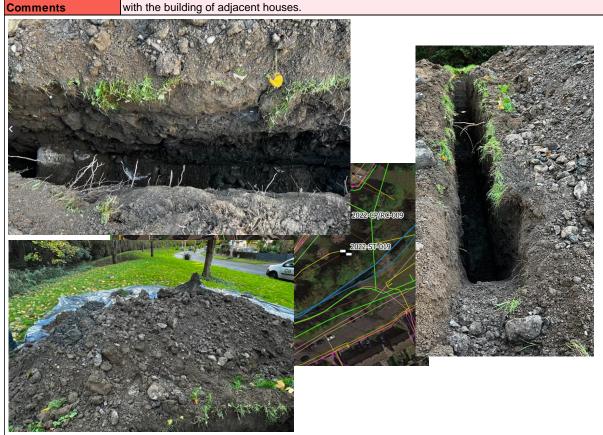
See Appendix 2, Plan 10.

Exploratory Hole ID	2022-ST-019
Date	23/11/2022
Depth	1.4m
Width	0.60m
Length	9.6m
Location	Brookdene
Depth	Description
0.00m-0.10m	Sod
0.10m-0.80m	Topsoil- mid brown silty clay.
0.80m-1.50m	Made ground- Dark grey sandy clay with moderate rounded cobble inclusions.
1.50m-1.70m	Natural ground-Dark grey sandy Dublin Boulder clay

Natural ground was exposed at a depth of 1.40m The eastern end of the trench disturbed from excavation of electricity cables. A made ground layer 1m in thickness overlay natural, associated with the building of adjacent houses.

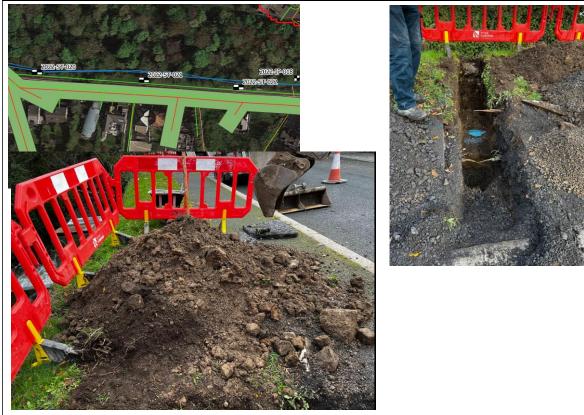
See Appendix 2, Plan 9.

Exploratory Hole ID	2022-ST-020
Date	22/11/2022
Depth	1.60m
Width	0.60m
Length	3m
Location	Commons Road
Depth	Description
0.00m-0.10m	Sod and topsoil- dark brown sandy clay
0.10m-0.50m	Made ground- dark brown silty sandy clay which contained frequent red and yellow bricks, a modren plank of wood and large rounded cobble inclusions
0.50m-1.80m	Made ground- possible redeposited natural a mid yellowish brown silty clay which contained occasional red brick inclusions.
Comments	Natural ground not exposed in this trench nor were any features/finds of archaeological significance. There were three pipes cutting through this trench at depths of 0.50m (service)

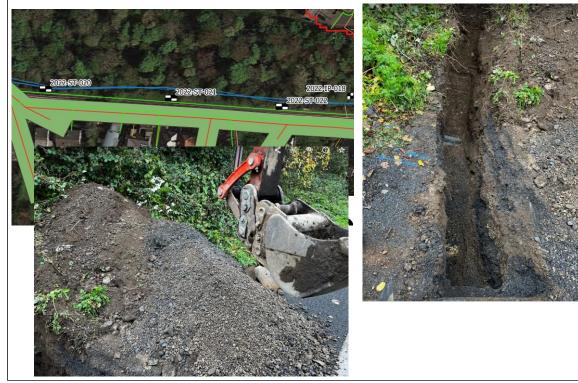
See Appendix 2, Plan 9.

Exploratory Hole ID	2022-ST-021
Date	22/11/2022
Depth	1.10m
Width	0.60m
Length	3.50m
Location	Commons Road
Depth	Description
0.00m-+0.80m	Stream bank- a dark brown silty sand.
0.0m-0.10m	Pavement- tar pavement
	Made ground- layers of grey 804, pea gravel which overylay three pipes visible in trench, one cut
0.10m-1.10m	conatined service pipes and the deepest at 1.10m contained gas.
	Natural ground not exposed in this trench nor were any features/finds of archaeological
Comments	significance. There were three pipes cutting through this trench at depths of 0.50m (service)

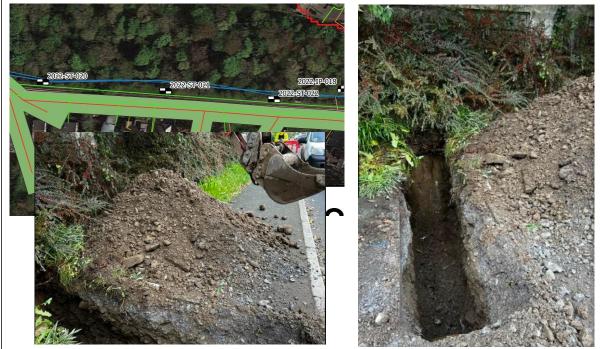
See Appendix 2, Plan 9.

Exploratory Hole ID	2022-ST-022
Date	22/11/2022
Depth	1.10m
Width	0.60m
Length	3.50m
Location	Commons Road
Depth	Description
0.00m-0.20m	Pavement- tar and harcdore
0.20m-0.1.50m	Made ground- mid greyish brown coarse sandy clay with moderate rounded cobble inclusions. Fill above three pipes.
0.70m-1.50m	Made ground- layers of grey 804, pea gravel which overylay three pipes visible in trench, one cut conatined service pipes and the deepest at 1.10m contained gas.
Comments	Natural ground not exposed in this trench nor were any features/finds of archaeological significance. There were three pipes cutting through this trench at depths of 0.90m (service) 0.70m (gas). The ground was completey disturbed to a depth of 1.50m under the footpath.

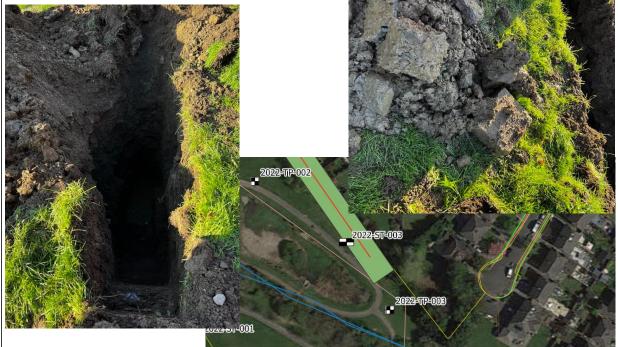
See Appendix 2, Plan 1.

Exploratory Hole ID	2022-TP-003
Date	25/11/2022
Depth	2.70m
Width	0.60m
Length	3m
Location	Belarmine
Depth	Description
0.00m-0.10m	Sod
0.10m-2.70m	Made ground- dark brown silty clay with modern debris inclusions, red brick modern pottery. Groundwater at 2.70m approx.
Comments	Natural ground not exposed. Trench comprised fill material which was used to landscape the park. Concrete blocks were uncovered at 2.70m BGL.

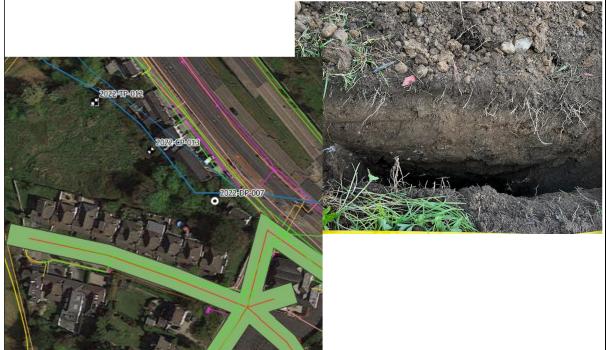
See Appendix 2, Plan 8.

Exploratory Hole ID	2022-TP-012
Date	25/11/2022
Depth	2m
Width	0.40m
Length	2.5m
Location	N11 Vet Clinic and Garage
Depth	Description
0.00m-0.10m	Sod
0.10m-1.10m	Made ground- mid yellowish silty clay with modern debris inclusions, red brick, plastic.
1.10m-1.80m	Made ground- mid brown stony clay.
	Natural ground?- Possible Dublin boulder clay, mid brown sandy clay with frequent large rounded
1.80m-2.00m	cobble inclusions.
	Natural ground?- Possible Dublin boulder clay, mid brown sandy clay with frequent large rounded
Comments	cobble inclusions exposed at 1.80m BGL.

At the N11 Veterinary Clinic the ground was overgrown and under rough pasture, one GI trench was excavated in this area (2022-TP-012). The uppermost horizon of this boulder clay was also possibly uncovered at the N11 Veterinary Clinic at GI pit 2022-TP-012.

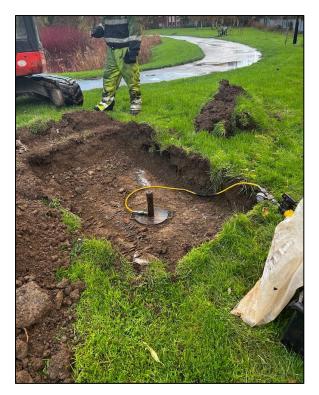
Plate 4: Plate test at Belarmine.

The GI works at Belarmine are in a landscaped park surrounded by apartments, schools, and houses (2022-TP-002-003 and 2022-ST-003) (Plate 4). A stream ran through the southern boundary of the site. The park comprised made up ground which was landscaped. A concrete block was recovered from a depth of 2.40m from the base of 2022 TP 003.

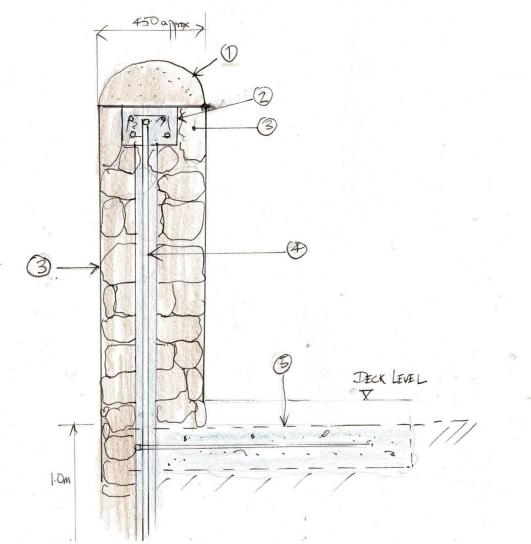
Sketch SA 202413/SK C1 Strengthening proposals to Shangangh Bridge parapet

- 1. Lift granite coping and relay in NHL3.5 mortar
- 2. 250x200 deep RC beam
- Cut top course of masonry and reset in NHL3.5 mortar. Point masonry in NHL3.5 mortar to SA spec
- 4. M20 Gr 8.8 steel bars at 750mm horizontal centres in 50m core filled with fine aggregate (10mm) concrete embedded at least
- 1.0m below deck structural level
   If required form frictional ties at 750mm centres formed in bridge structural deck level

Grout voids where bedding mortar has disintegrated with Coulinex NHL 3,5 grout to conservation engineer's specification.

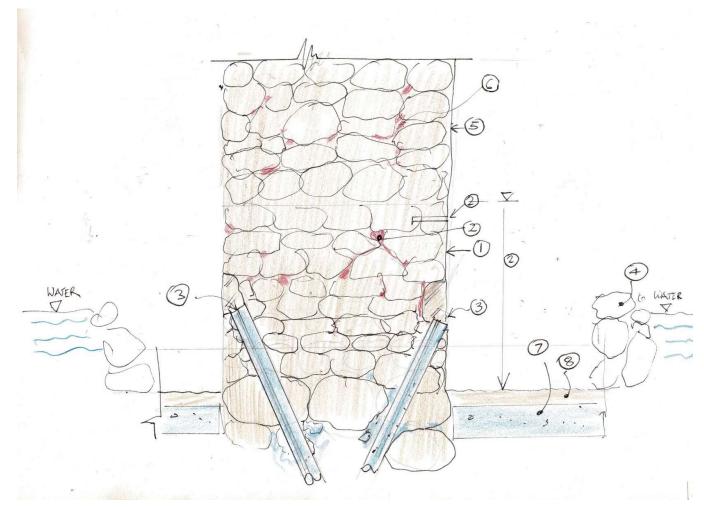
Sketch SA 202413/SK C2 Shanganagh Bridge- Consolidation of piers and abutments

- 1. Repoint bottom 1m in NHL 5 Prompt fast setting mortar for marine works.
- 2. Carefully grout masonry in NHL 5 prompt introduce grout with hand pump in 20mm hoes at 450mm c/c to SA specification.
- 3. After grouting Mini piling to specialist details. Remove stone to set piles within piers and abutments and original stone footing. Allow concrete to flow into voids under pressure between boulders and in gravelly water bearing pockets.
- 4. Point above 1m level in NHL3.5
- 5. Grout with Coulinex NHL 3,5
- 6. PVC sheeting and ply deck to avoid environmental contamination during works.
- 7. Anti-scouring slab set below bed level.
- 8. Silt to disguise slab.

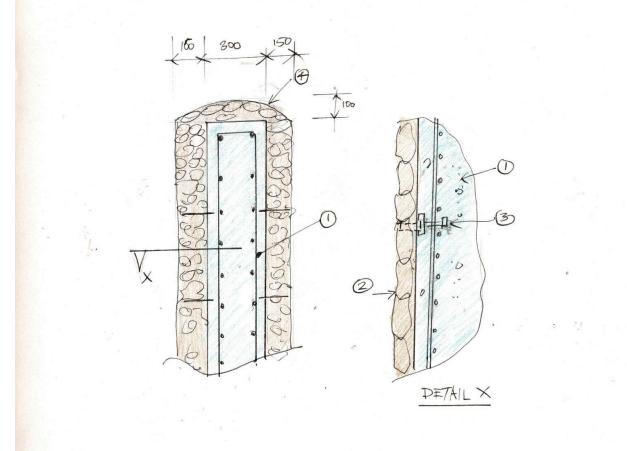
Sketch SA 202413/SK C3 New flood relief wall cladding and capping

- Reinforced concrete flood wall to engineer's specifications.
- Reclaimed stone facing in M4 (1:1:6) mortar with 5-7mm grot nd pinning stones to conservation engineer's specification.
- Halfen or similar cast in restraint channels at 750mm horizontal centres with masonry ties at approximately 450mm vertical centres.
- 4. Domed mortar capping in M4 (1:1:6 ) mortar with flat stones 10 to 20mm deep as per conservation engineer's specification.

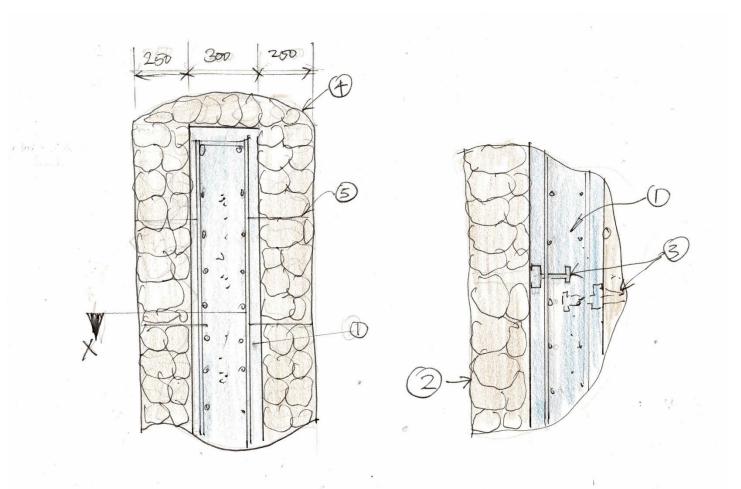
Sketch SA 202413/SK C4 |variation at Kilgoblin using 250mm masonry to maximise reclaiming of original wall fabric and texture. This wall cladding is built in lime mortar without expansion joints in order to reflect the original character

- 1. Reinforced concrete flood wall to engineer's specifications.
- Reclaimed stone facing in NHL 3.5 lime mortar with 5-7mm grit and pinning stones
- 3. Halfen or similar cast in restraint channels at 750mm horizontal centres with masonry ties at approximately 450mm vertical centres.
- 4. Domed mortar capping in NHL 3.5 lime mortar with flat stones 10 to 20mm deep as per conservation engineer's specification.

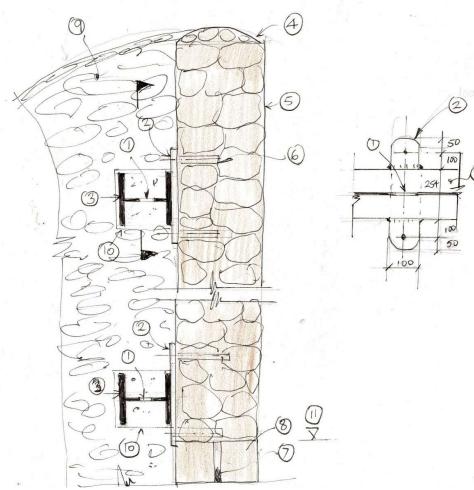
#### 1. Cut weep holes in web 50mm diameter at 750mm c/c.

- !00x550mm x 20 grade 316 stainless steel plate welded to U|C with 5mm fillet weld all around with 2 no 20mm holes for Hiltu resin anchors.
- 3. 254x254x73 UC Grade 316 stainless steel or similar to engineer's specifications

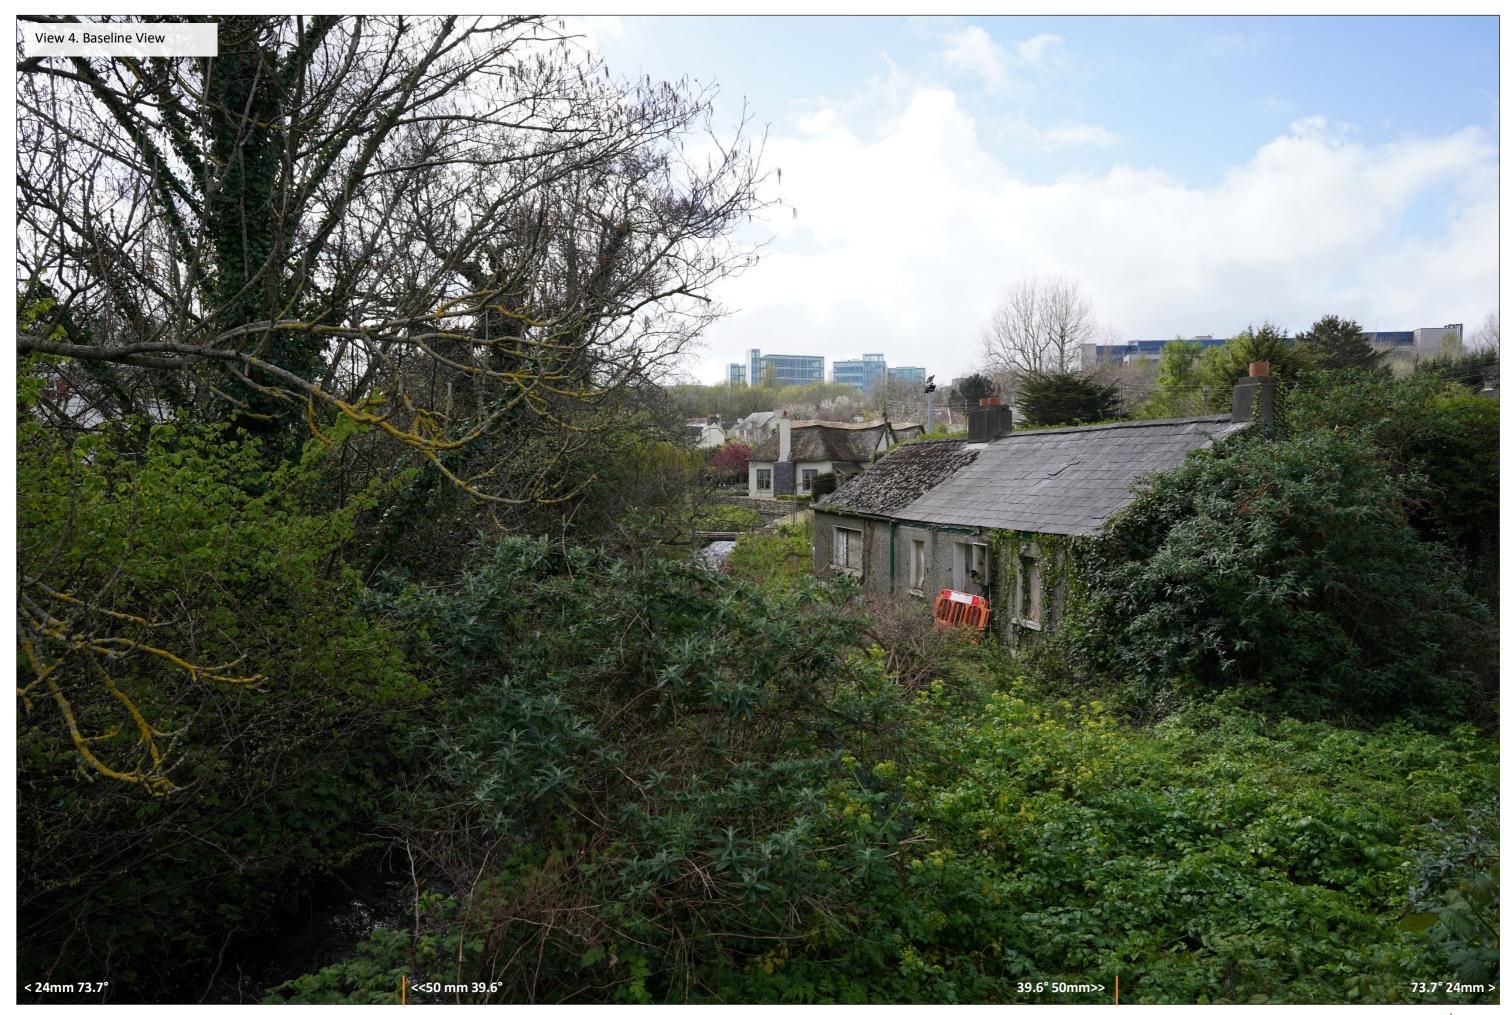
Photo Date: 05.04.2024 Photo Time: 13:46 Camera: Sony a7RIII Viewpoint Location: At Castle View, looking south towards the proposed walls. Viewpoint Coordinates (ITM): 721916.297;724159.766;66.377

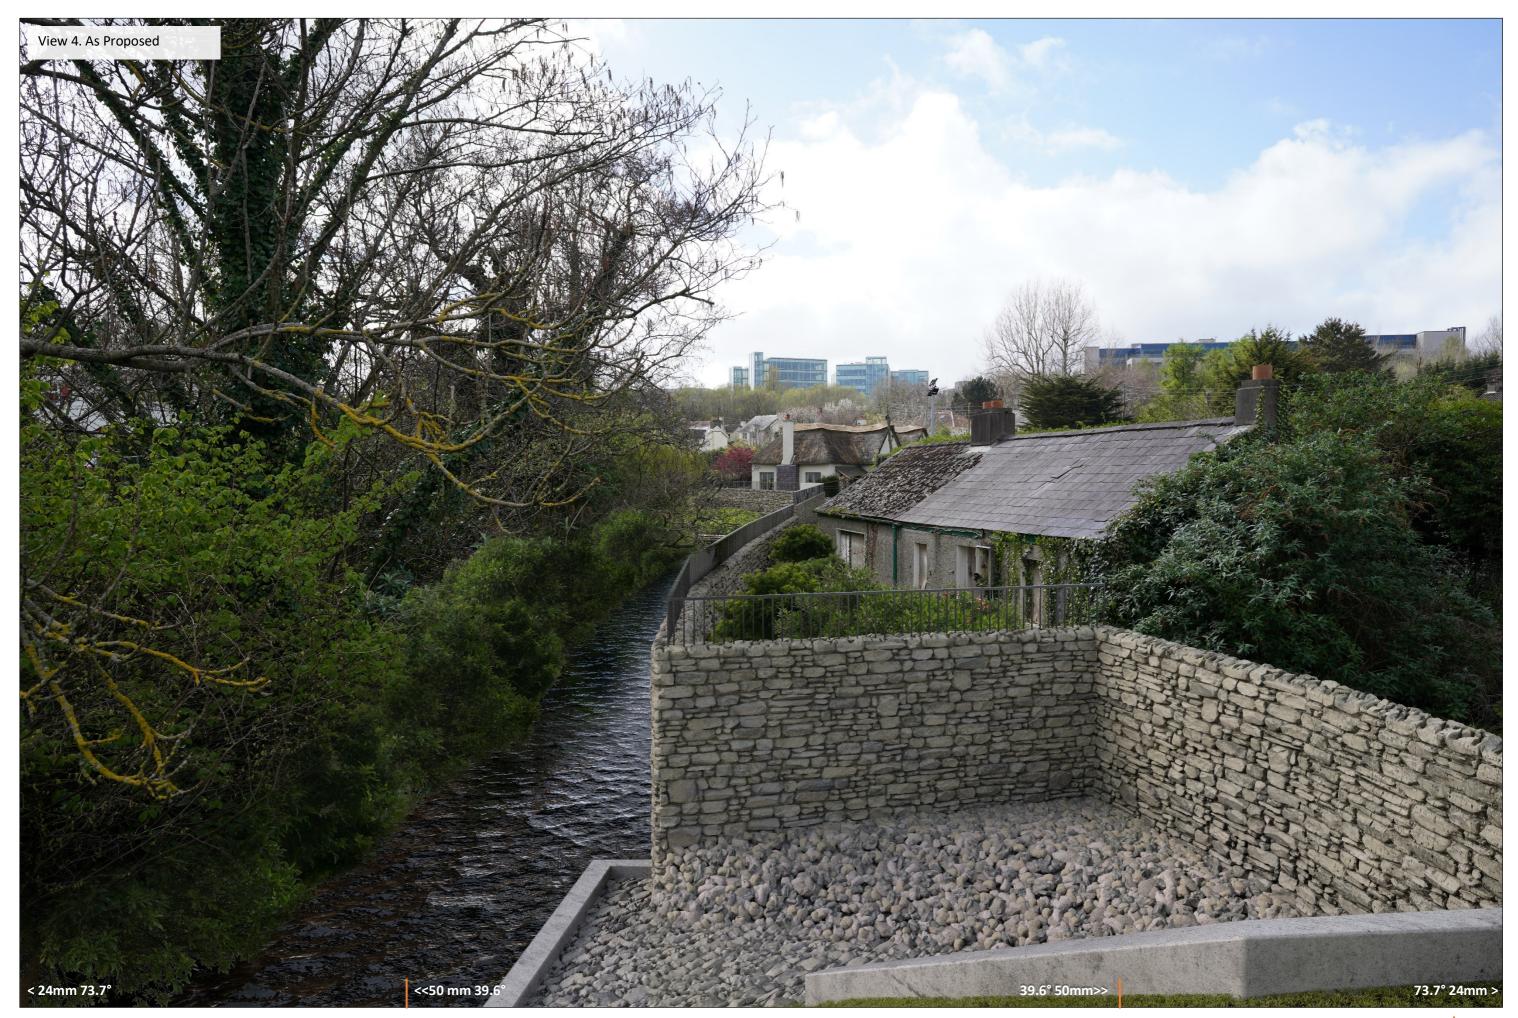
Photo Date: 05.04.2024 Photo Time: 14:09 Camera: Sony a7RIII

Viewpoint Location: At Loughlinstown Road, looking upstream towards the proposed walls at Waterfall Cottage. Viewpoint Coordinates (ITM): 724521.092;723248.045;16.780

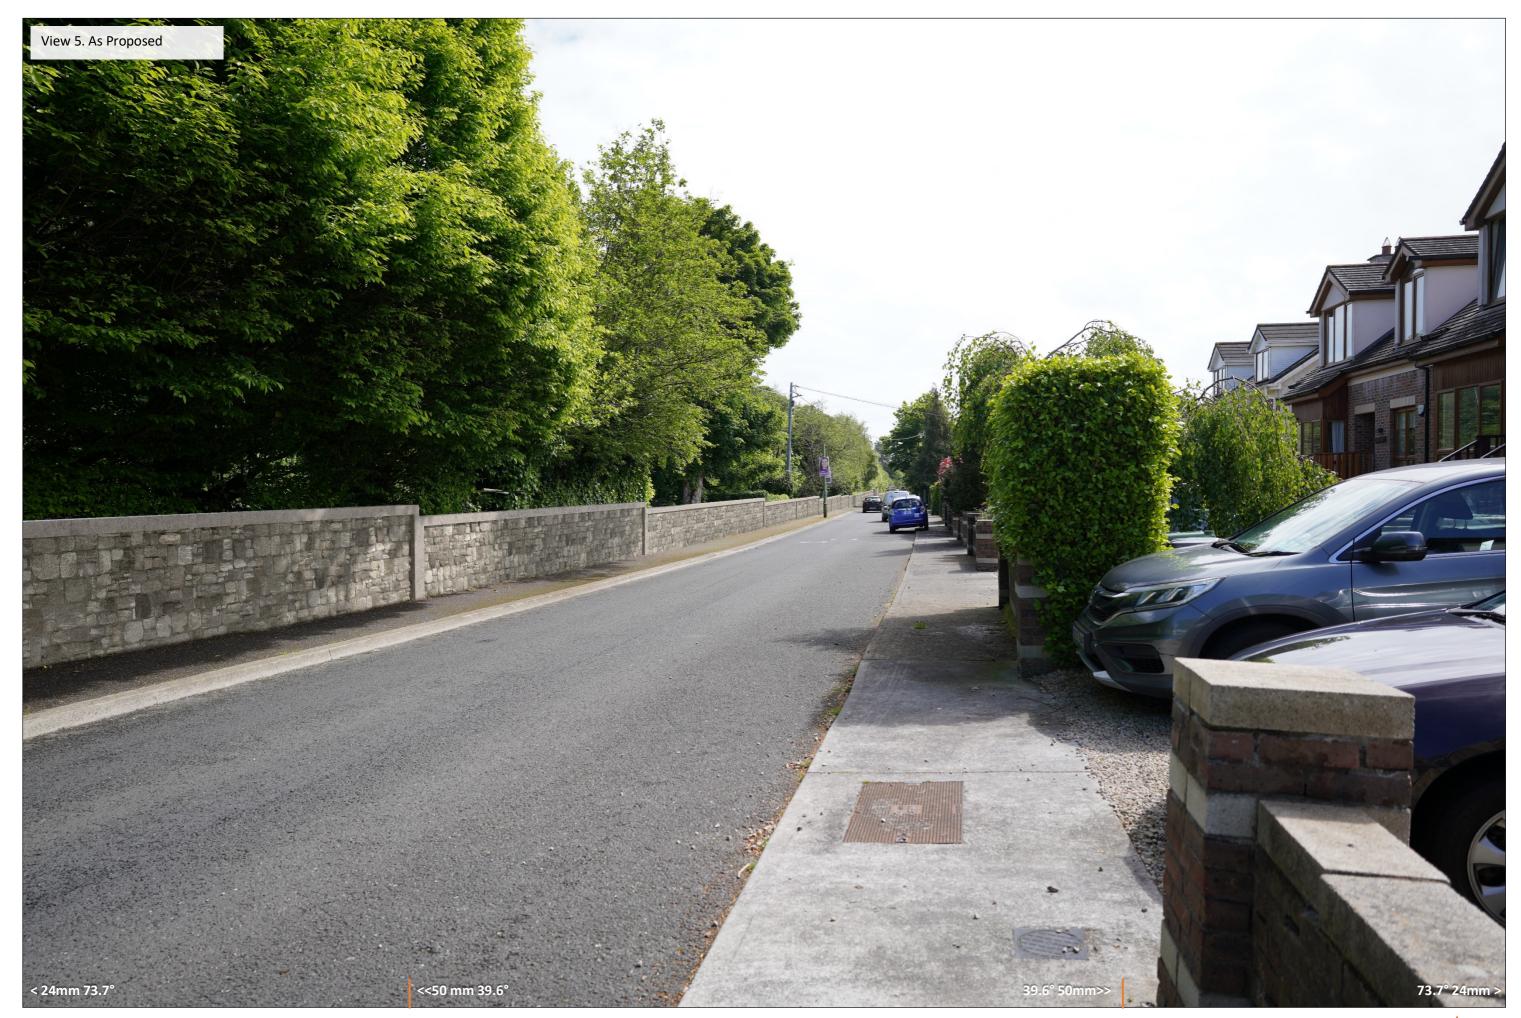
Photo Date: 14.05.2024 Photo Time: 11:49 Camera: Sony a7RIII

Viewpoint Location: On Commons Road, at the western end of the proposed flood wall, looking east. Viewpoint Coordinates (ITM): 724951.594;723000.520;11.597
