# Carrickmines-Shanganagh River Flood Relief Scheme EIAR – Volume 3 Appendices

February 2025

This report relates to the Carrickmines-Shanganagh River Flood Relief Scheme commissioned by Dún Laoghaire-Rathdown County Council (DLRCC), on behalf of the Office of Public Works (OPW). Conor O'Neill and Bernadette O'Connell of JBA Consulting compiled this report, which was prepared by the competent experts listed in Table 1-1 of Volume 2, Chapter 1.

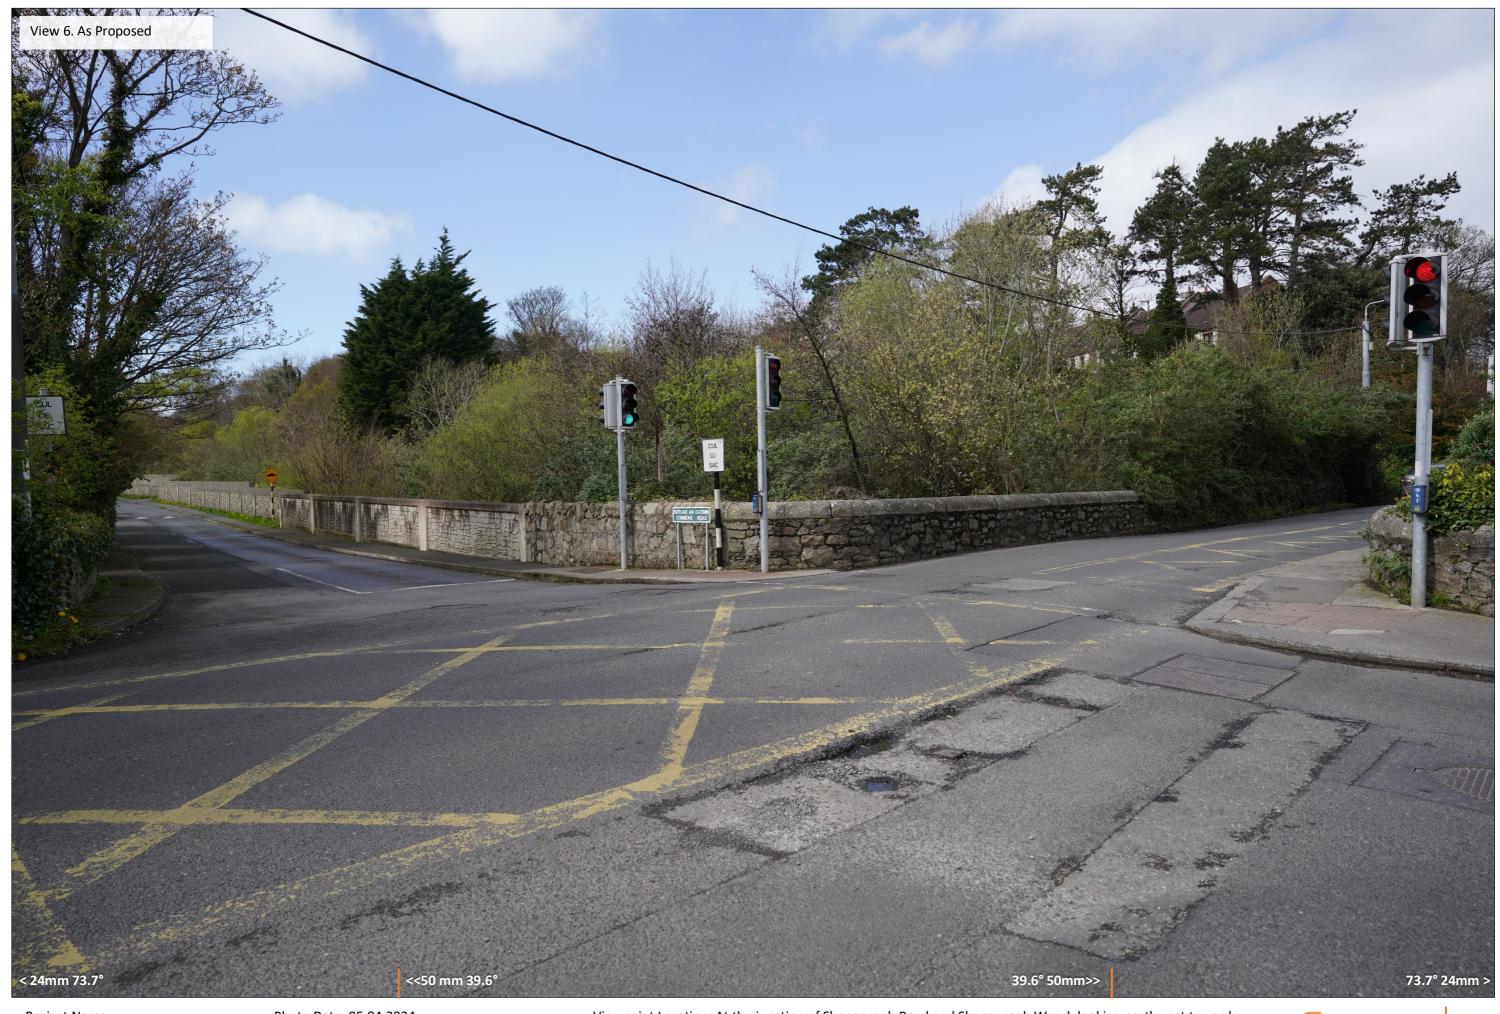
Photo Date: 05.04.2024 Photo Time: 14:42 Camera: Sony a7RIII

Viewpoint Location: At the junction of Shanganagh Road and Shanganagh Wood, looking northwest towards Shanganagh Road Bridge and Commons Road Viewpoint Coordinates (ITM): 725376.230;722964.402;9.078

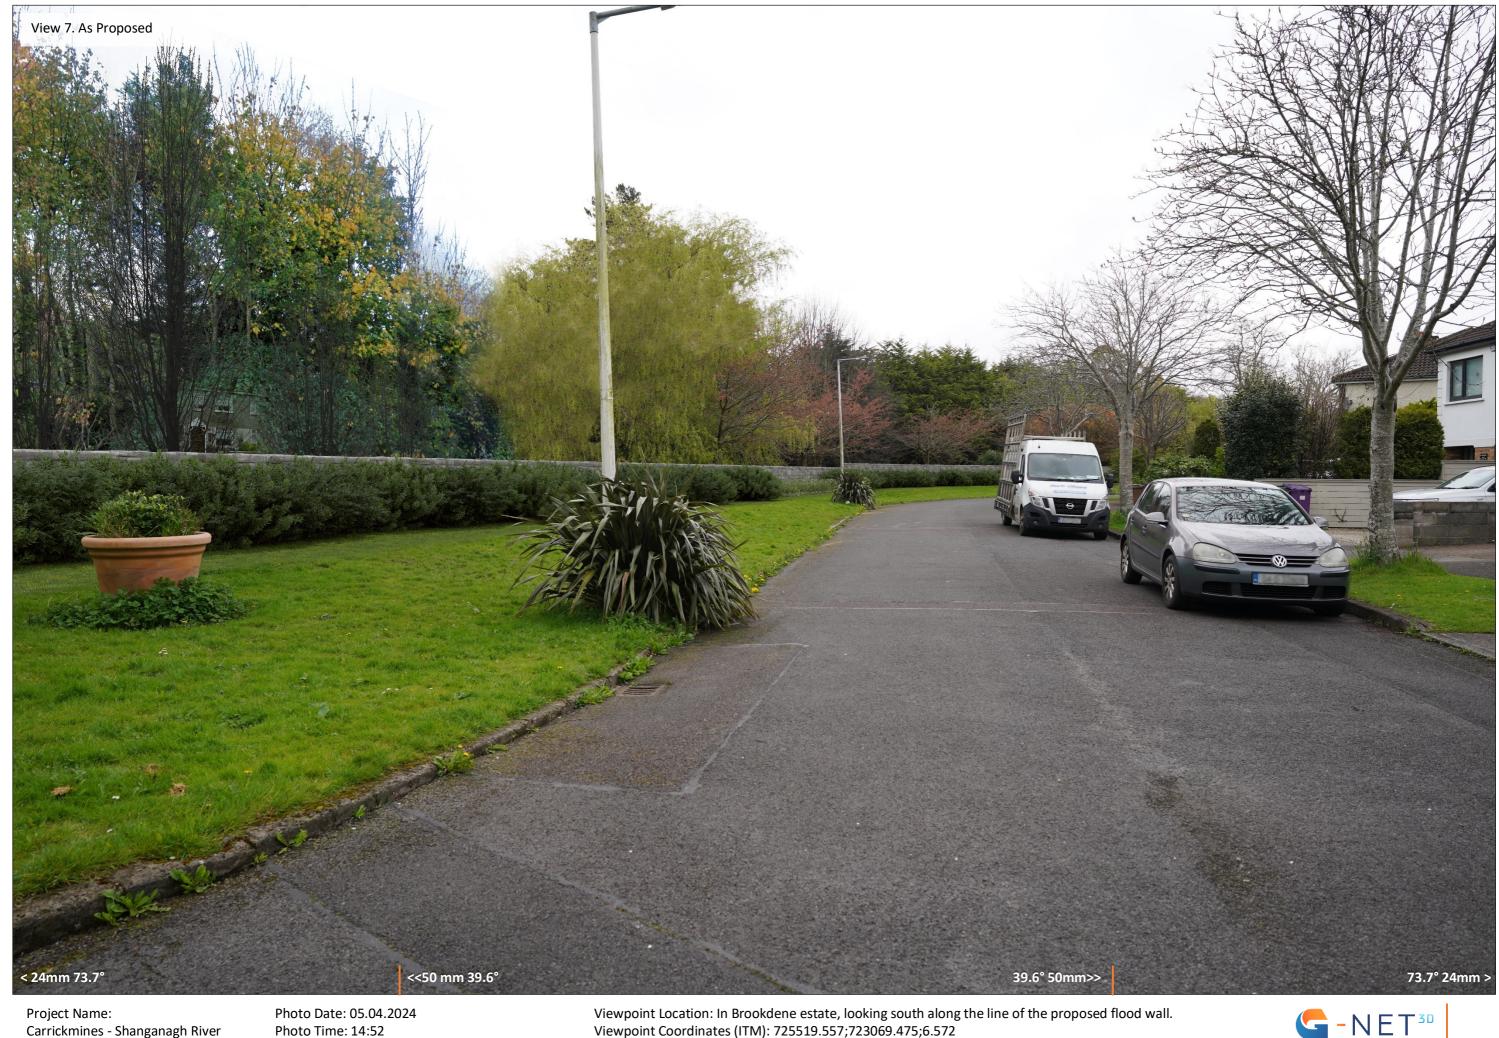
Photo Time: 14:52 Camera: Sony a7RIII Viewpoint Location: In Brookdene estate, looking south along the line of the proposed flood wall. Viewpoint Coordinates (ITM): 725519.557;723069.475;6.572

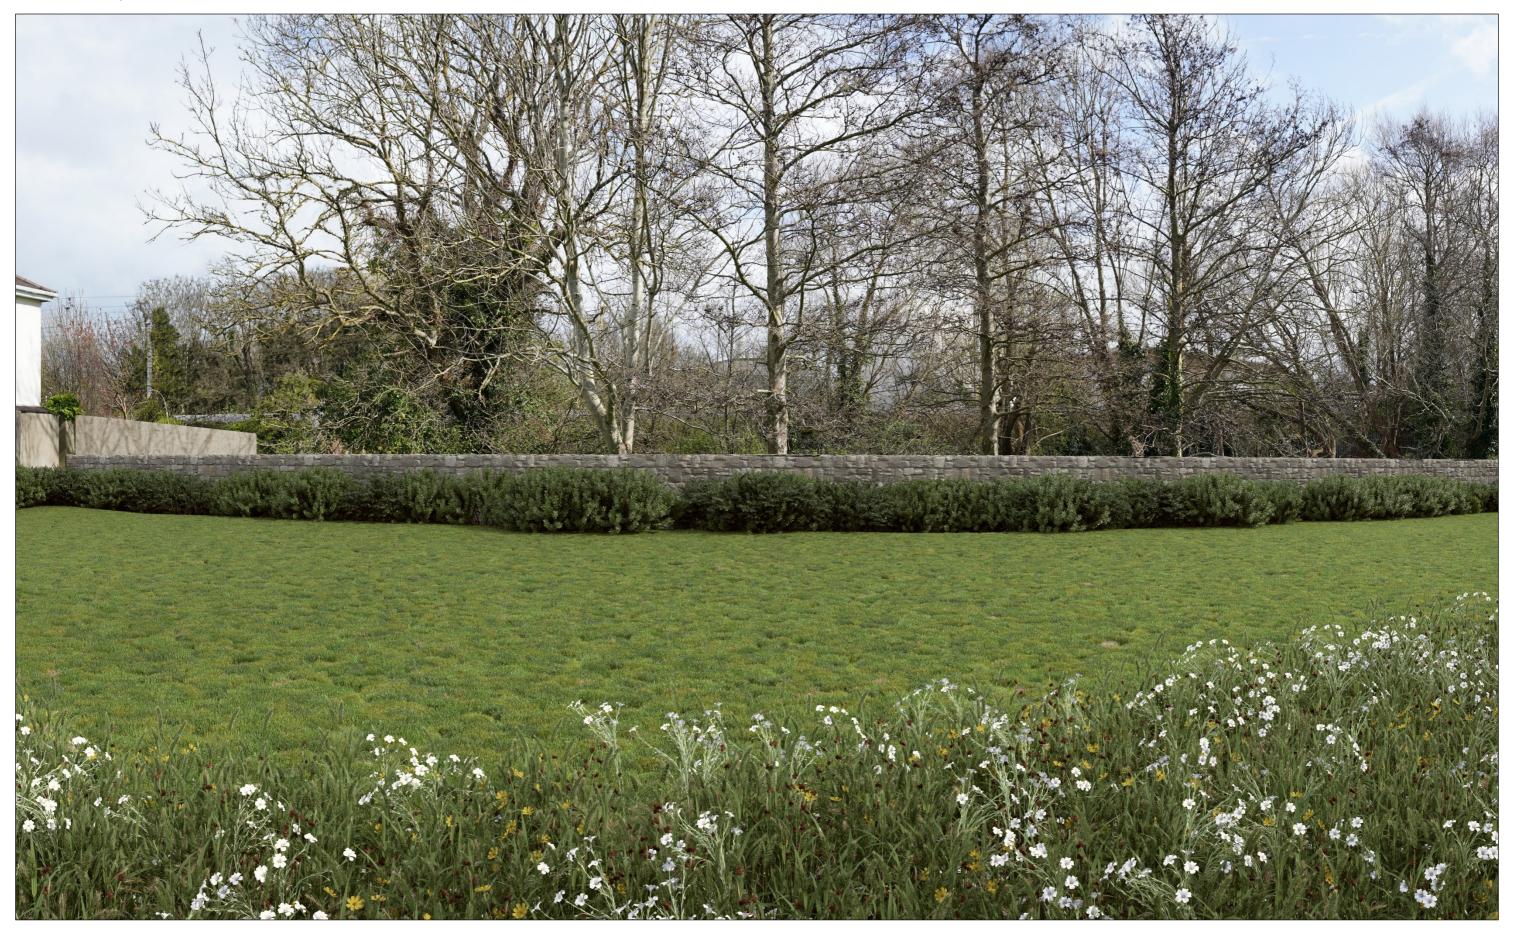
Photo Date: 05.04.2024 Photo Time: 15:08 Camera: Sony a7RIII Viewpoint Location: In Bayview Lawns, looking east at the proposed flood wall. Viewpoint Coordinates (ITM): 725640.127;723251.034;6.458

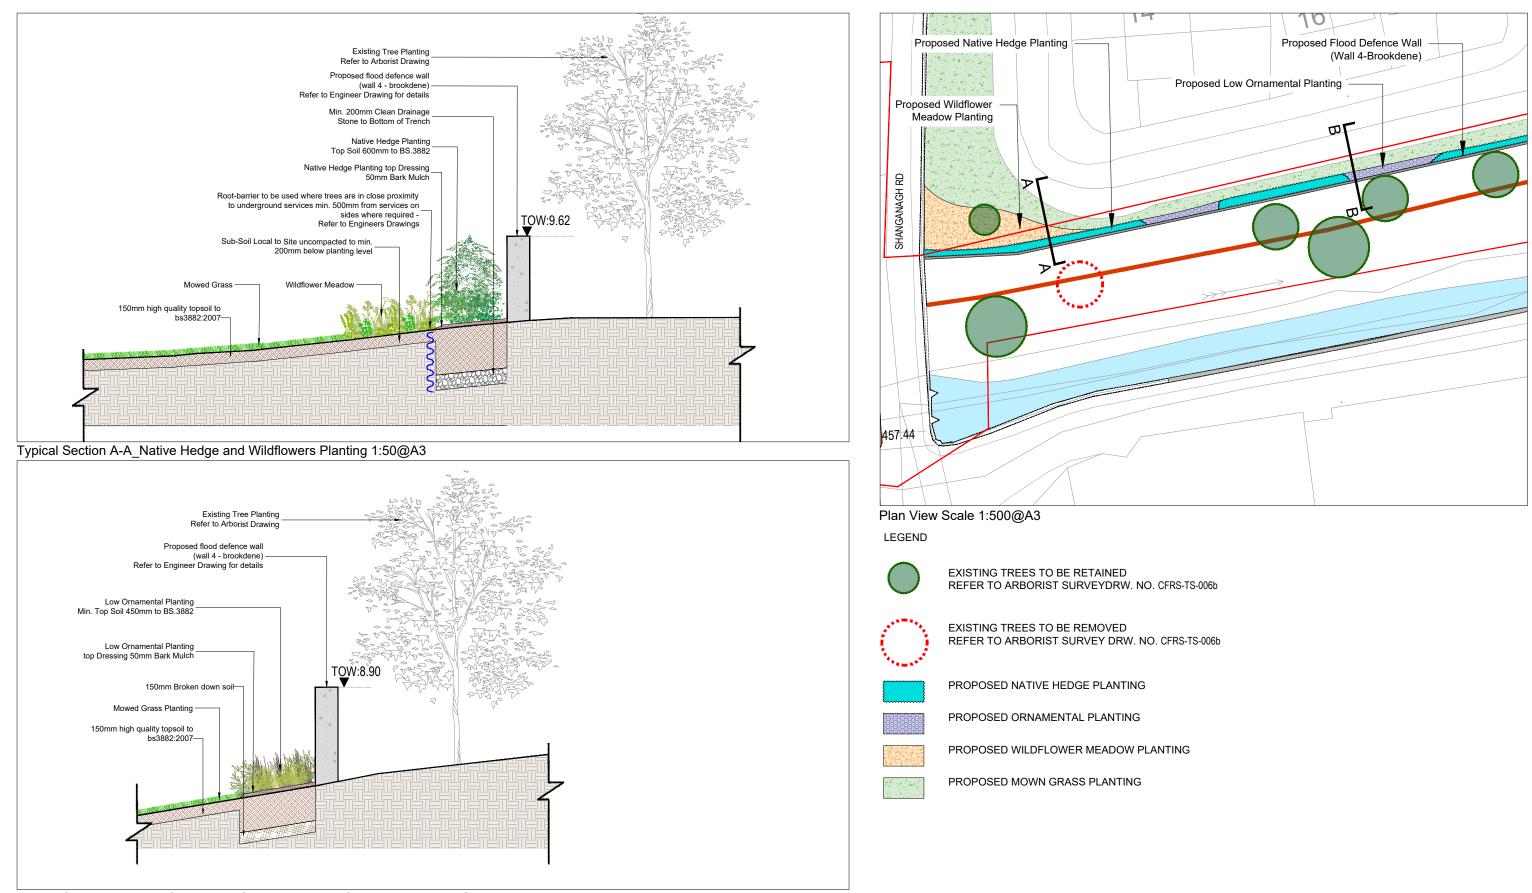
Drawing Number 20108-JBA -XX-XX-DR-L-0002 Drawing Title: Brookdene Typical Landscape Sections & Plan View

Typical Section B-B\_Low Ornamental Shrub and Mown Grass Planting 1:50@A3

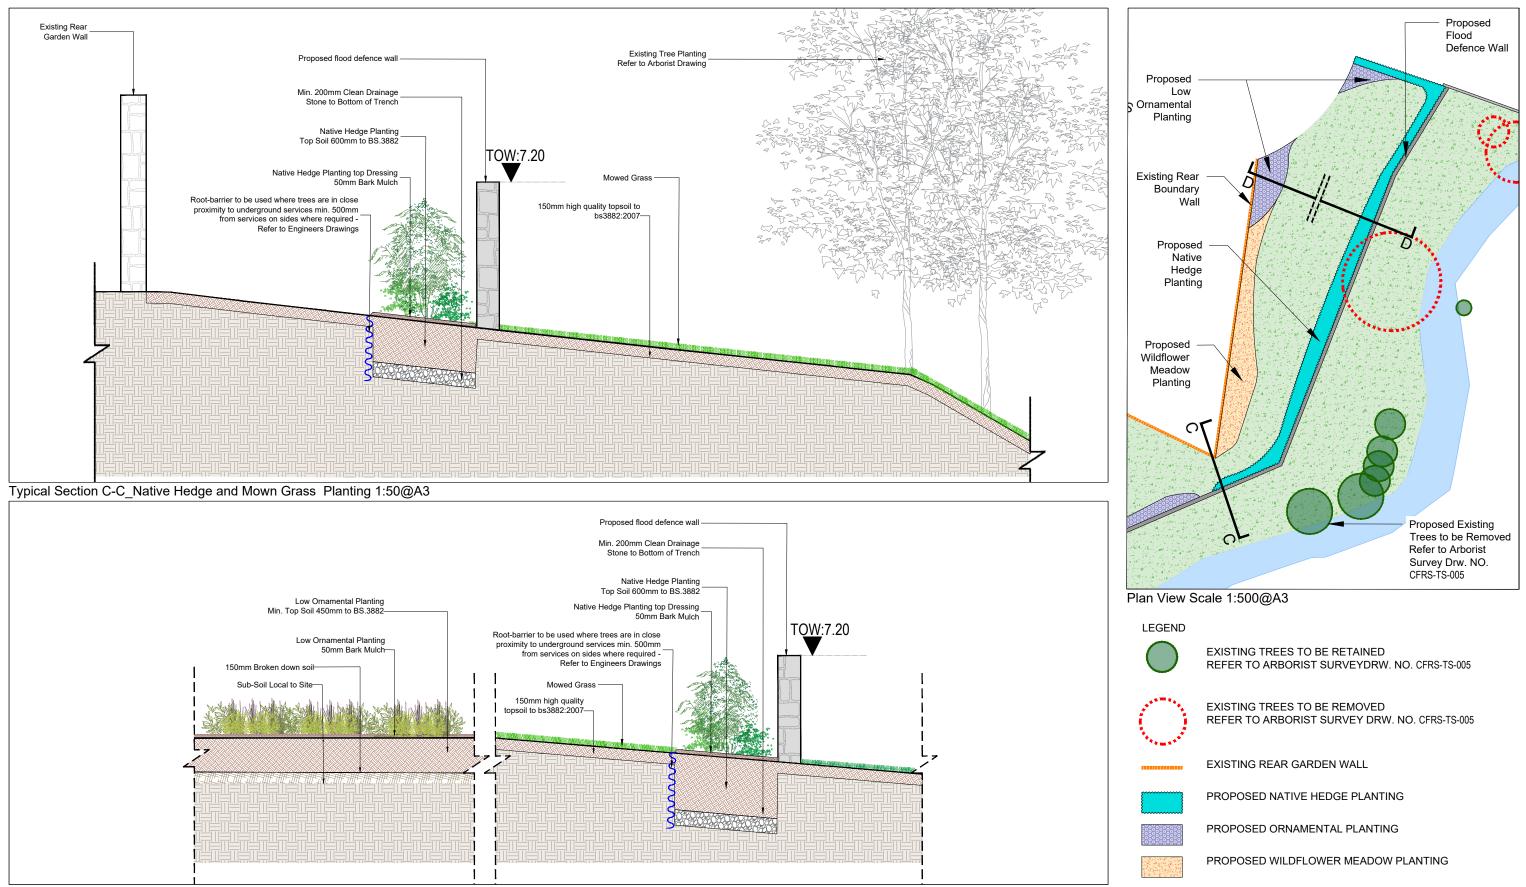
Typical Section D-D\_Low Ornamental Planting, Native Hedge and Wildflower Meadow Planting 1:50@A3
